# Investigation information release

## Fatality in underground opal mine

**Event:** Fatality in an underground opal mine

**Location:** Coocoran opal field.

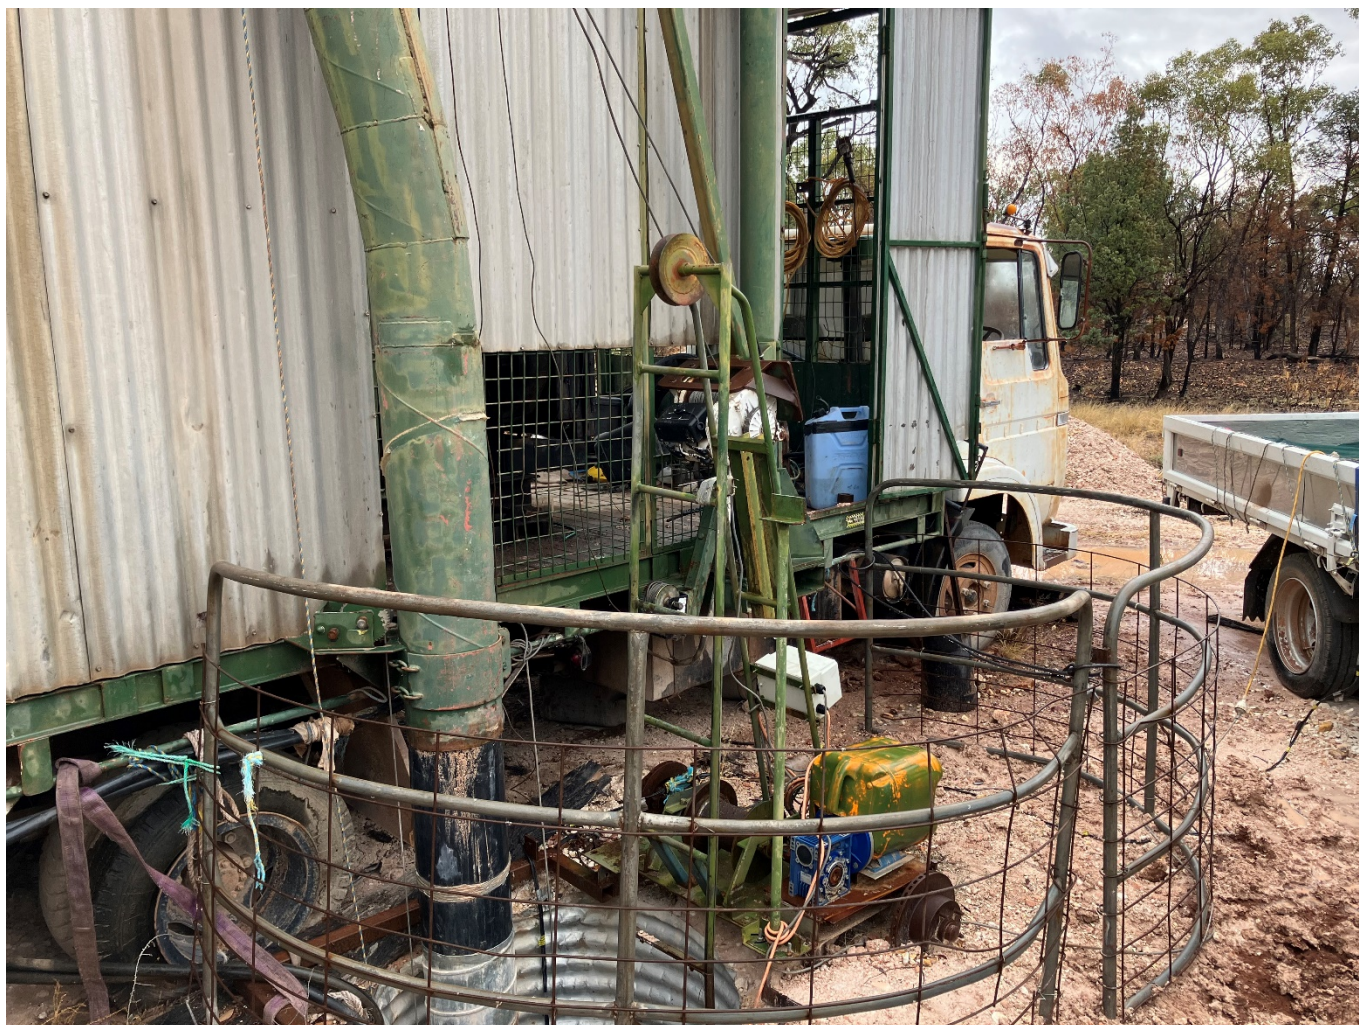
Figure 1: MC 61376 with hoist and ladder/rails to person riding hoist

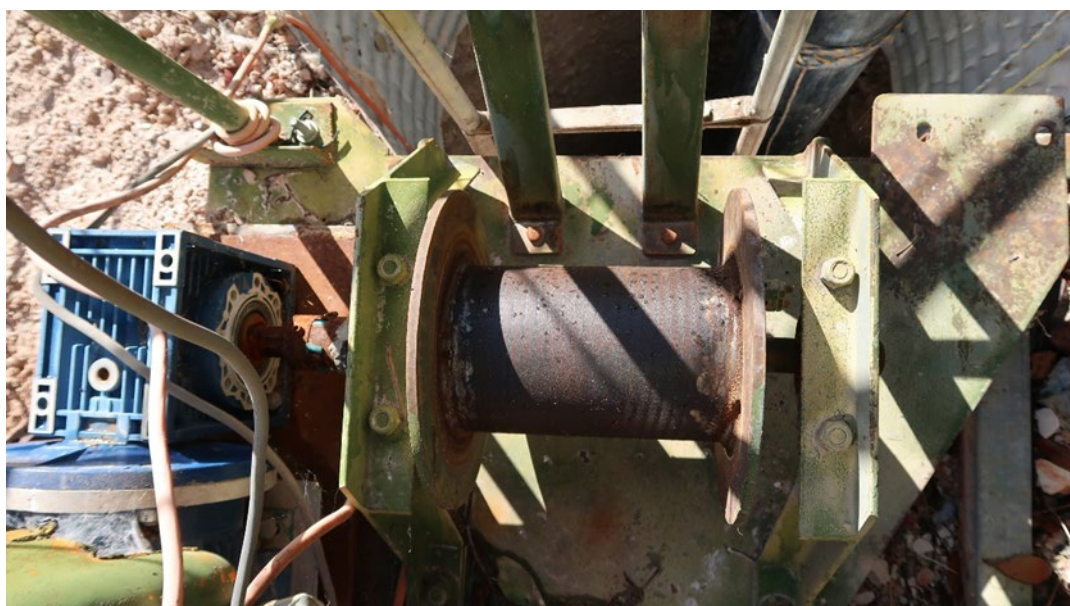
An examination of the scene found the person riding hoist and pendant control at the bottom of the shaft with the steel cable fully unspooled from the hoist's drum. The hoist's emergency arresting (lockout) device did not appear to have engaged. The hoist was operated by a Conon single phase 2 HP motor and worm drive gearbox.

Figure 2: Cable from hoists drum was found completely unspooled

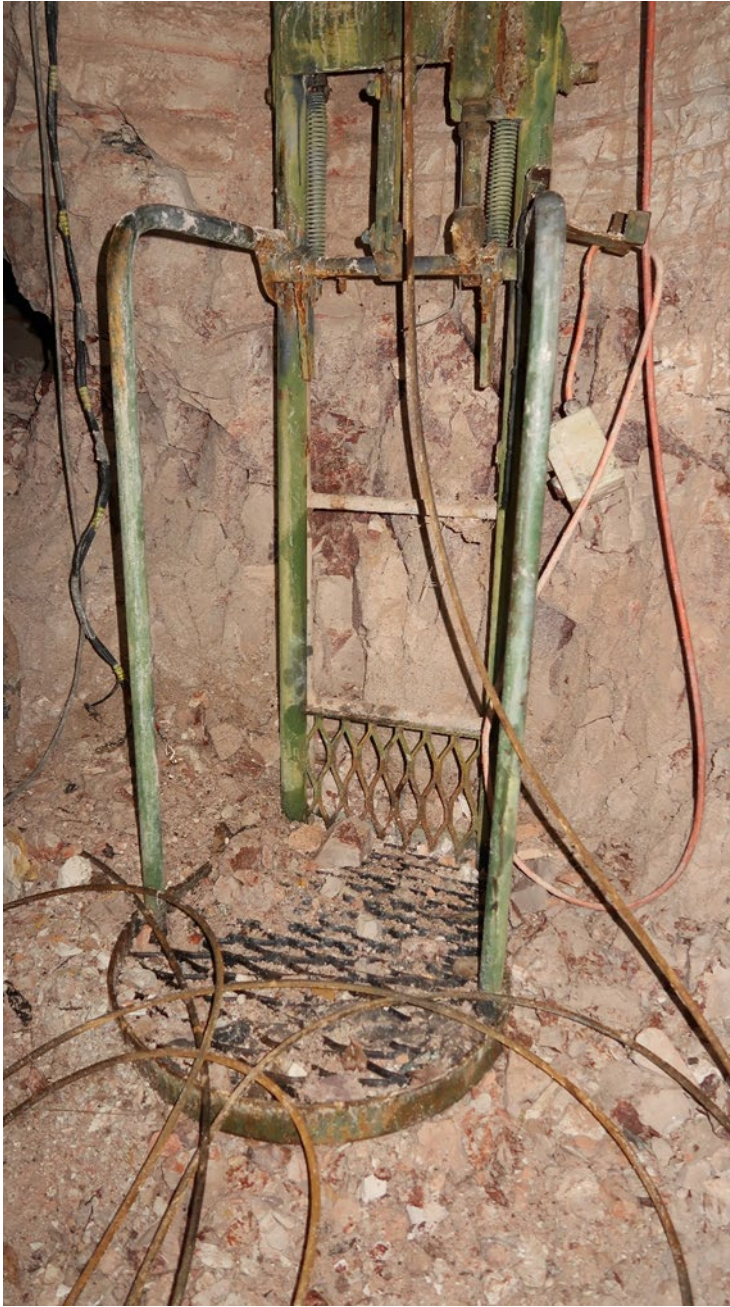
Figure 3: Person riding hoist found at the bottom of the shaft with unspooled cable. Note the safety breaking system has not engaged

All hoists must have 2 braking systems – a brake and an emergency arrestor.

Person riding hoists should be regularly tested and maintained to ensure they are operating correctly.
