# Investigation information release

## Fatality in underground opal mine

**Event:** Fatality in an underground opal mine

## Investigation information release IIR23-04

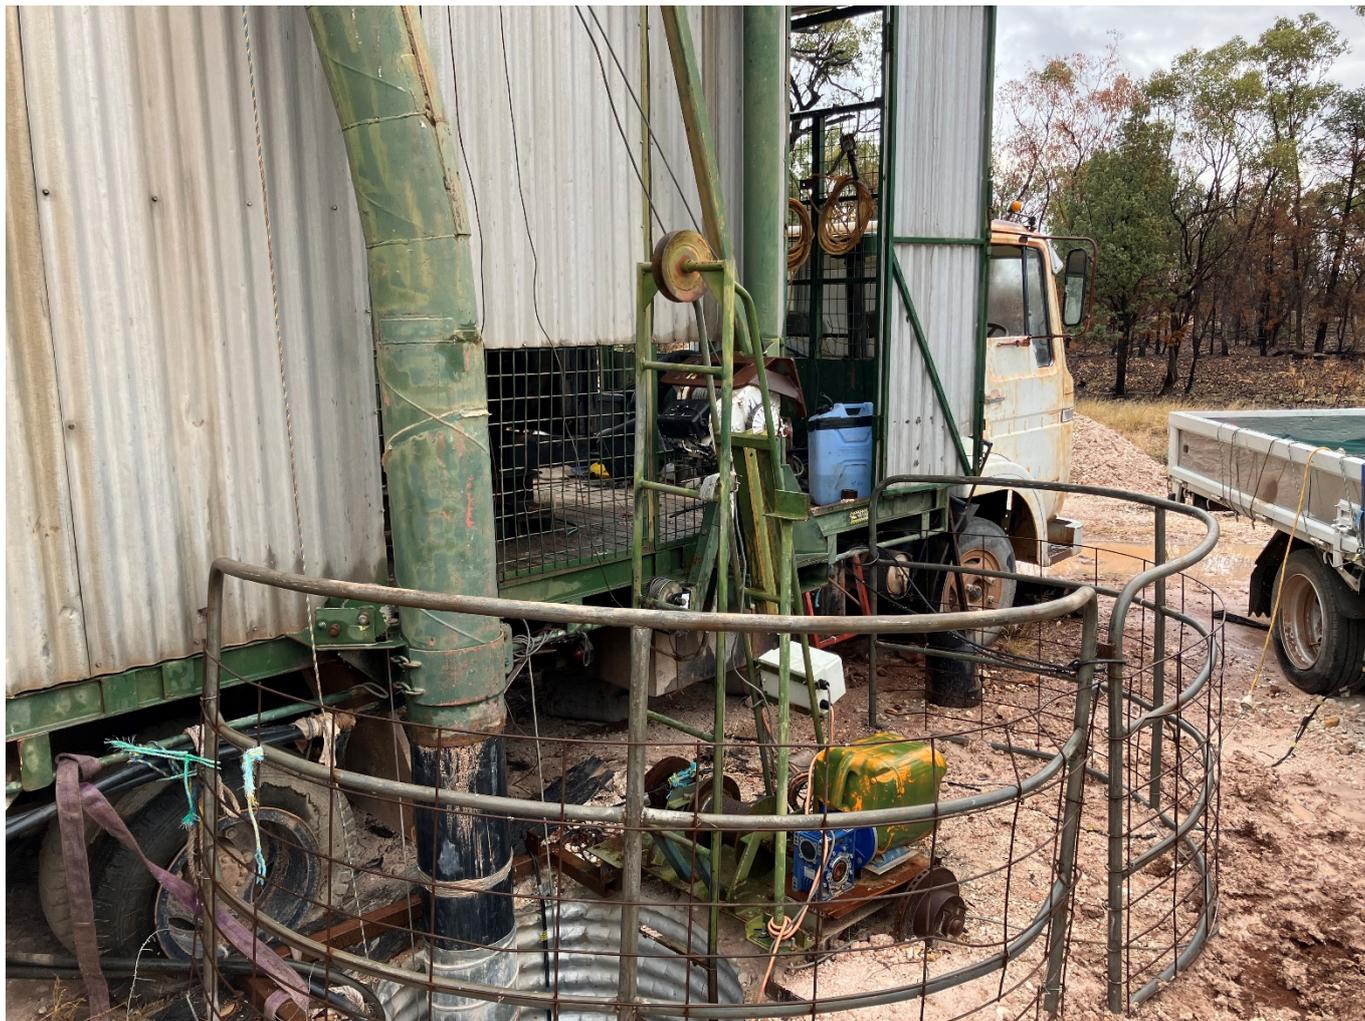
Figure 1: MC 61376 with hoist and ladder/rails to person riding hoist

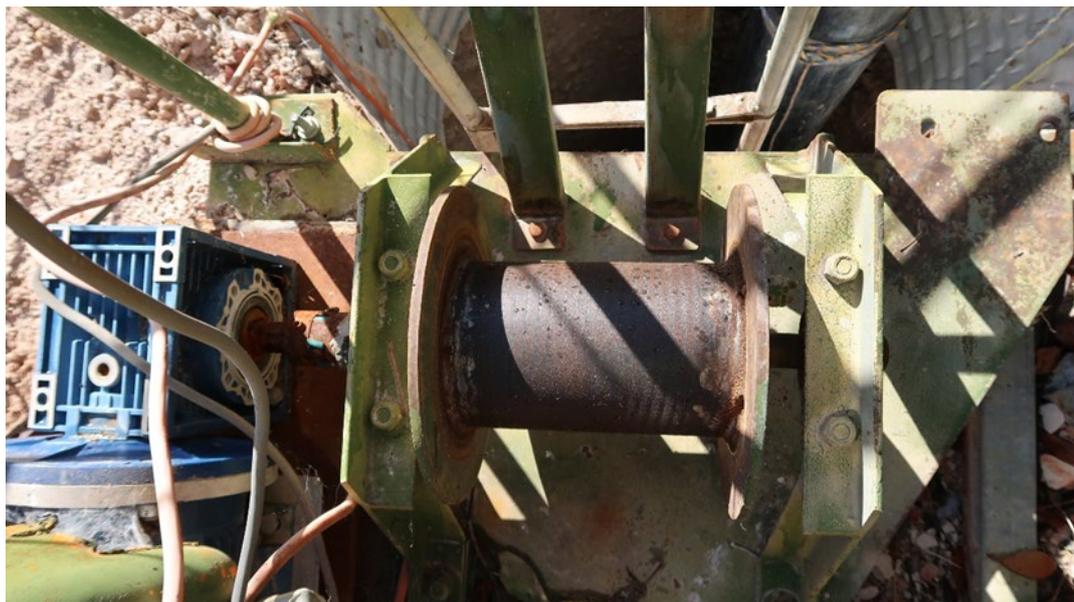
An examination of the scene found the person riding hoist and pendant control at the bottom of the shaft with the steel cable fully unspooled from the hoist's drum. The hoist's emergency arresting (lockout) device did not appear to have engaged. The hoist was operated by a Conon single phase 2 HP motor and worm drive gearbox.

Figure 2: Cable from hoists drum was found completely unspooled

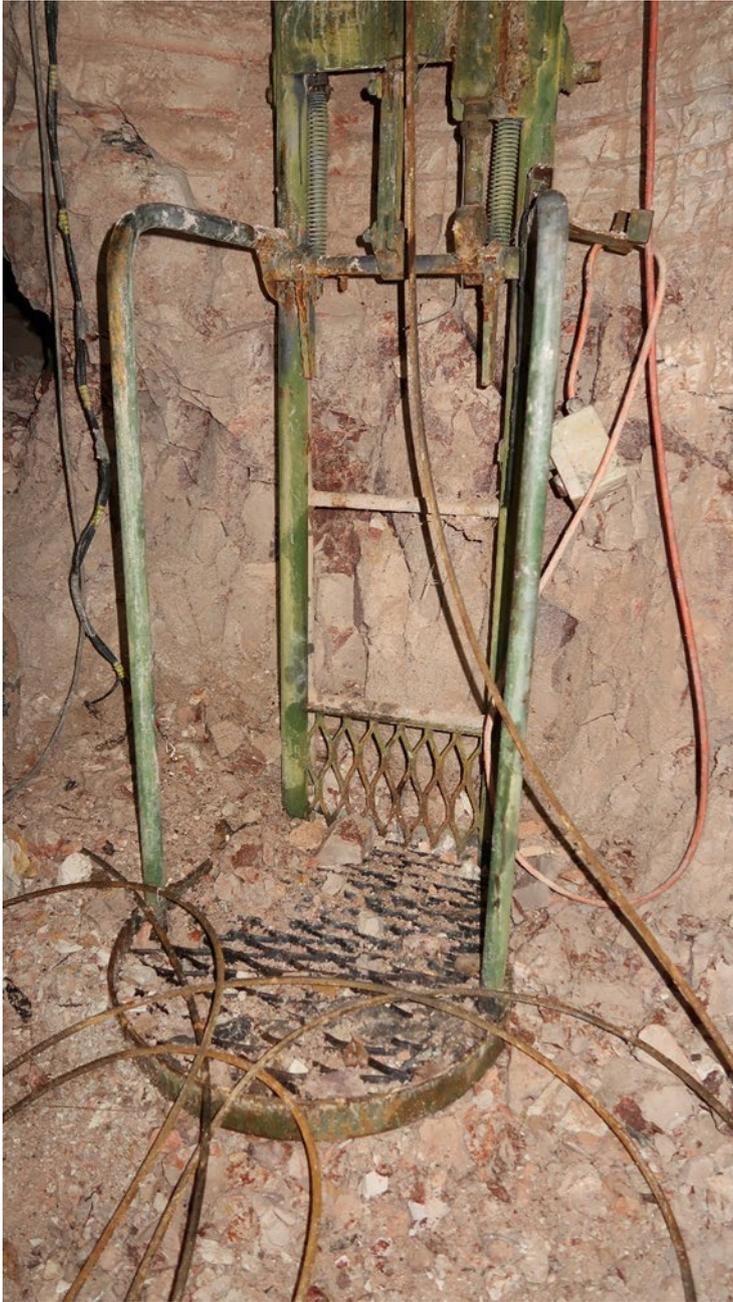
Figure 3: Person riding hoist found at the bottom of the shaft with unspooled cable. Note the safety breaking system has not engaged

All hoists must have 2 braking systems – a brake and an emergency arrestor.

Person riding hoists should be regularly tested and maintained to ensure they are operating correctly.
