# Investigation information release

## Serious injury of a Jumbo offsider during drilling work

**Event:** Serious injury of a worker while fitting a drill steel to a Jumbo

**Location:** Cadia East Underground Mine

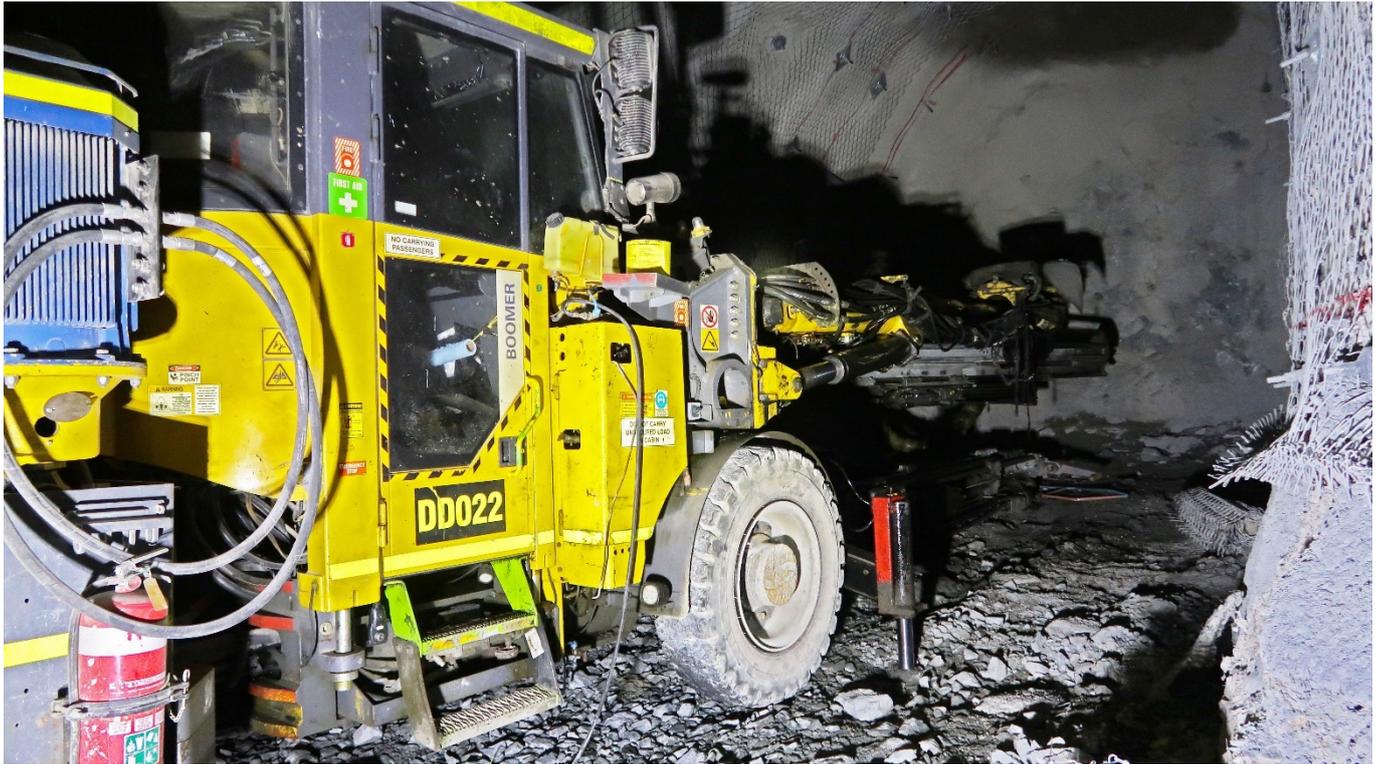
Figure 1: Jumbo drill rig DD022 at the incident scene

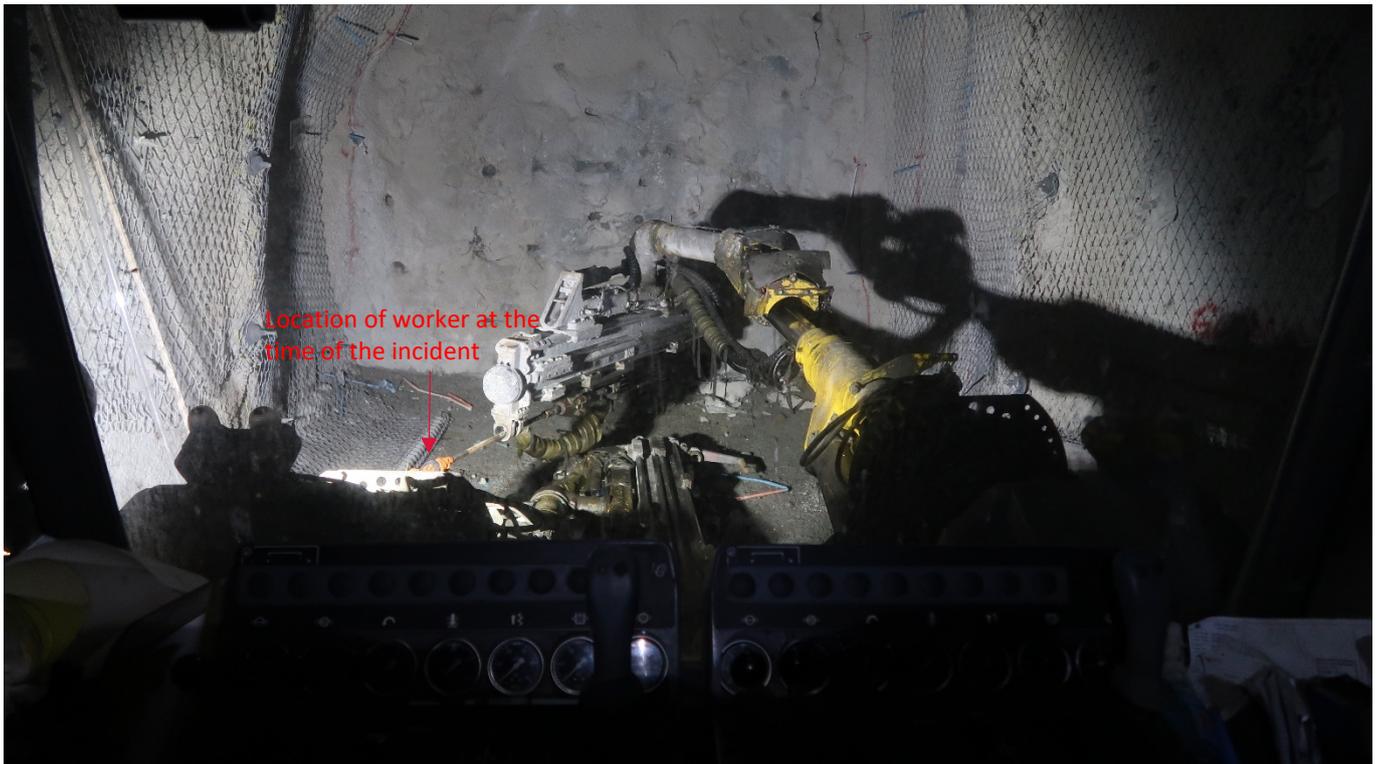
Figure 2: View of the Jumbo booms from the operator cabin as found by investigators

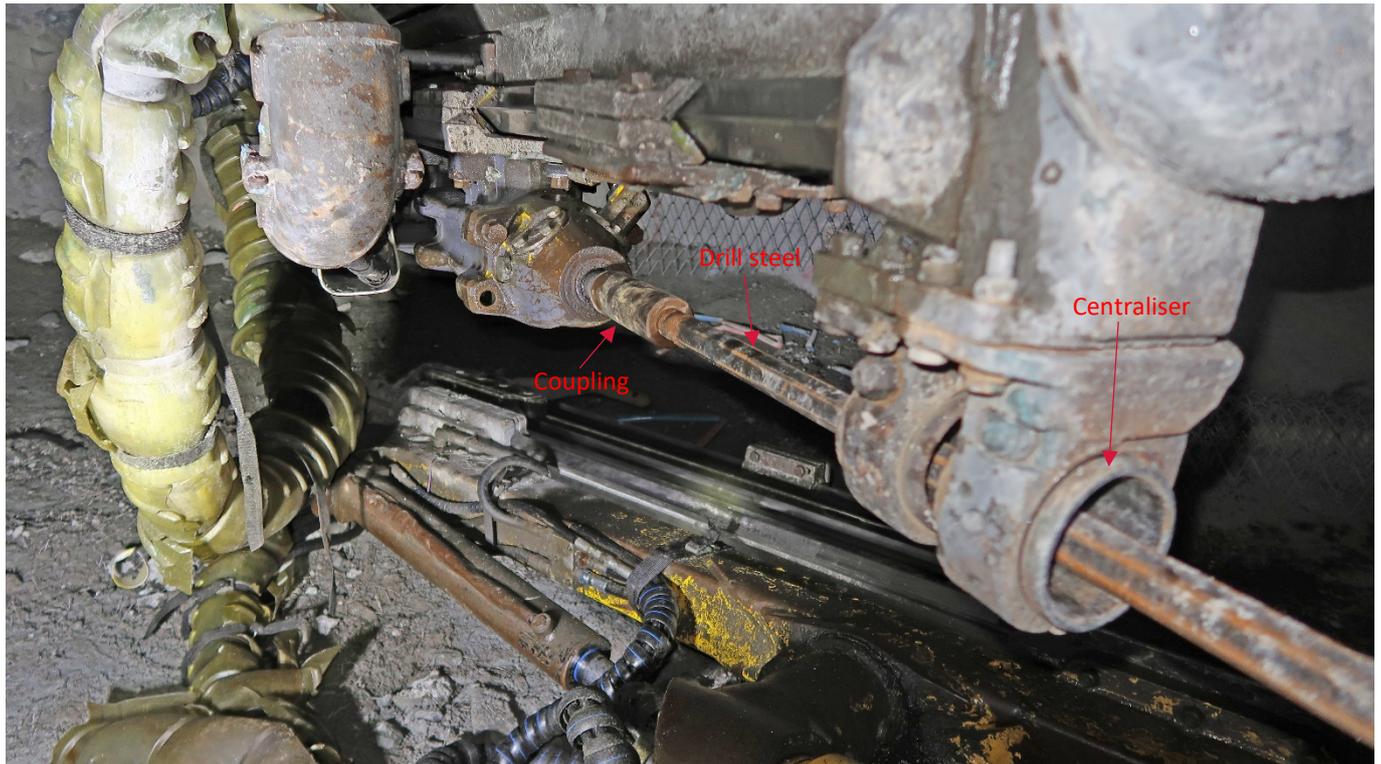
Figure 3: Drill steel inserted into coupling on the righthand drill

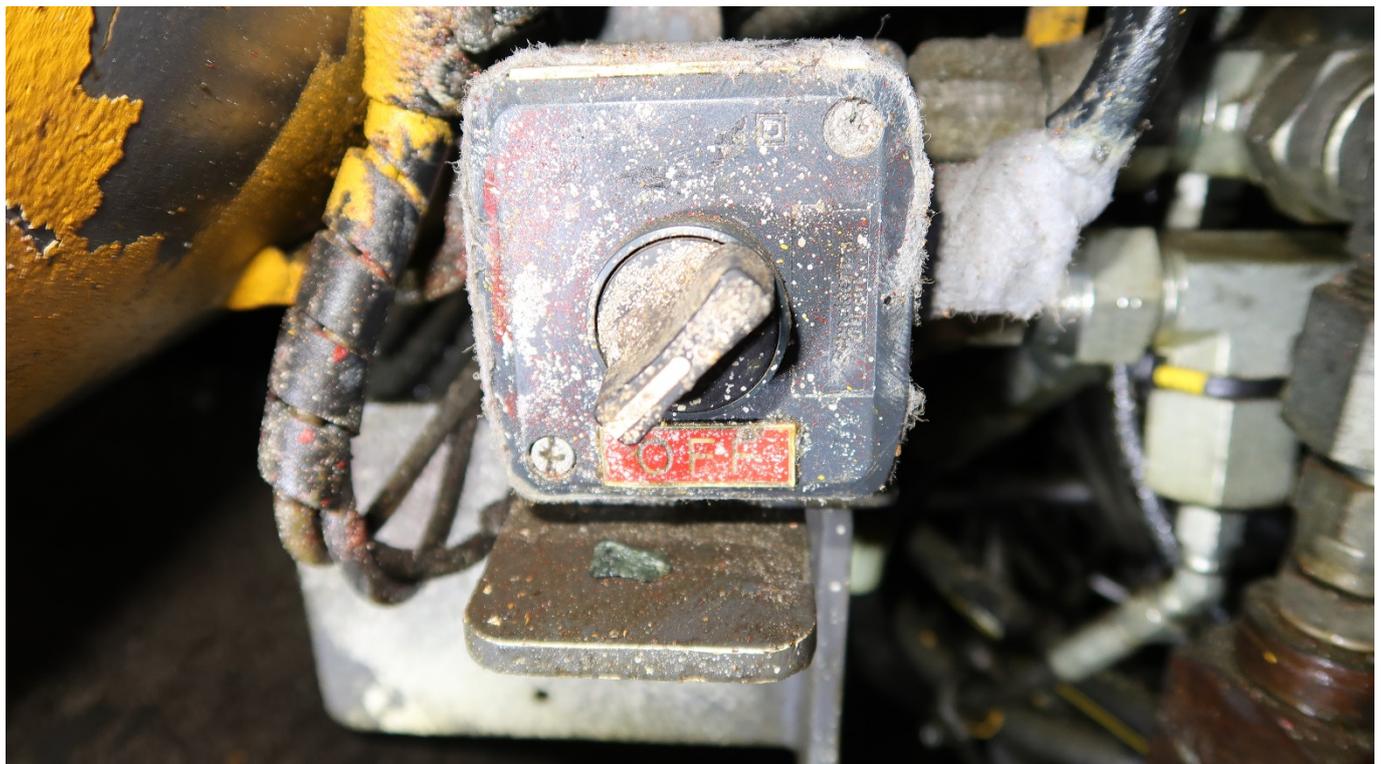
Immobiliser switches used to isolate power to the booms are positioned on the front left and right sides of the Jumbo (figure 4). The offsider approached the front of the Jumbo to change a component on the righthand boom, which was angled back towards the left side of the Jumbo. The worker inserted a 3.7 metre drill steel into the coupling of the righthand boom as the coupling rotated. The offsider's left arm became entangled on the rotating drill steel, resulting in traumatic amputation to his left arm below the elbow. An emergency response was activated resulting in the offsider being transported to the surface and then airlifted to hospital for treatment.

Figure 4 Immobiliser switch on the front left side of the Jumbo with isolation switched off

- implement a safe system of work that requires workers to isolate plant before attempting to remove, change or insert components, including drill steels
- provide workers with adequate instructions and training about how to control risks to health and safety associated with changing components on mobile plant, including Jumbo drill rigs, that is commensurate with their experience and the risk
- ensure that isolation points on mobile plant are functioning, clearly marked and easily accessible.

- isolate Jumbo drill rig booms when working on or near the booms
- be aware that removing, changing or inserting components into moving machinery presents a significant entanglement risk
- ensure they comply with the mine operators' safe work procedures, hazard identification and risk management processes.
