Investigation information release

Electrician injured from an arcing flash

Location: Appin Mine North (Westcliff colliery), Appin, NSW.

Investigation information release IIR25-06

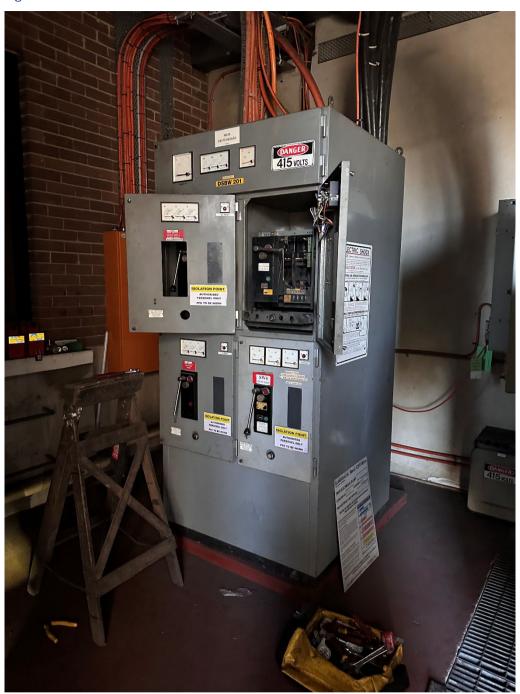
Figure 1: The distribution board involved in the incident

Two electrical tradespersons had completed an internal inspection on a workshop 415V distribution board (DSBW202) at 1.15 pm on 7 June 2025. They were at the isolation point, trying to close the circuit breaker (ACB1) in distribution board (DSBW201).

While investigating the function of closing the circuit breaker ACB2, which is adjacent to ACB1, the circuit breaker racking handle was used as a levering tool. During the process, the racking handle inadvertently made contact with a live phase and the enclosure frame (i.e. earthed) causing a phase-to-earth fault and a subsequent arc blast. As a result, one of the workers suffered arc flash burns to his left hand.
