Weekly incident summary

Week ending 22 August 2025

This incident summary provides information on reportable incidents and safety advice for the NSW mining industry. To report an incident to the NSW Resources Regulator: phone 1300 814 609 24 hours a day, 7 days a week.

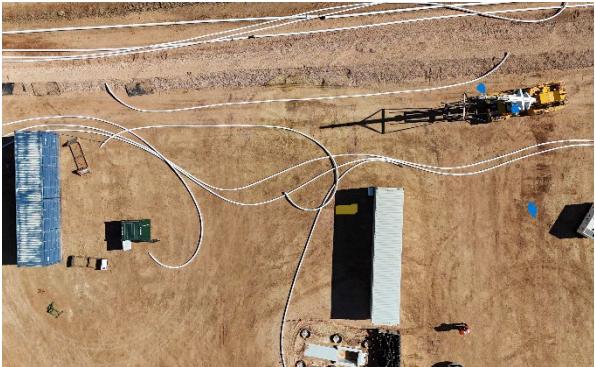
Incident type	Summary	Comm to industry
Dangerous Incident IncNot0049667 Surface Operations Leave blank	During construction work, a worker (IP) was installing high-pressure pipe when a coil of pipe recoiled unexpectedly, striking the worker's head. The pipe was being unspooled from a 3-meter-tall wooden frame. While the IP was positioned approximately 10 meters from the work area behind a shipping container, the loose end of the pipe unspooled and struck the ground with enough force to rebound and strike the IP's helmet above the ear. The impact caused the worker to lose consciousness for about 20 seconds. The helmet cracked upon impact. The IP was transported to the hospital for further examination. Initial findings suggest the amount of stored energy in the pipe was	Mine operators must ensure that the hazard of pipe recoil is identified in relevant risk assessments and appropriate controls are implemented to prevent workers being exposed to the relevant risk.

Incident type	Summary	Comm to industry
	<p>greater than in previous spools, contributing to the severity of the recoil</p>

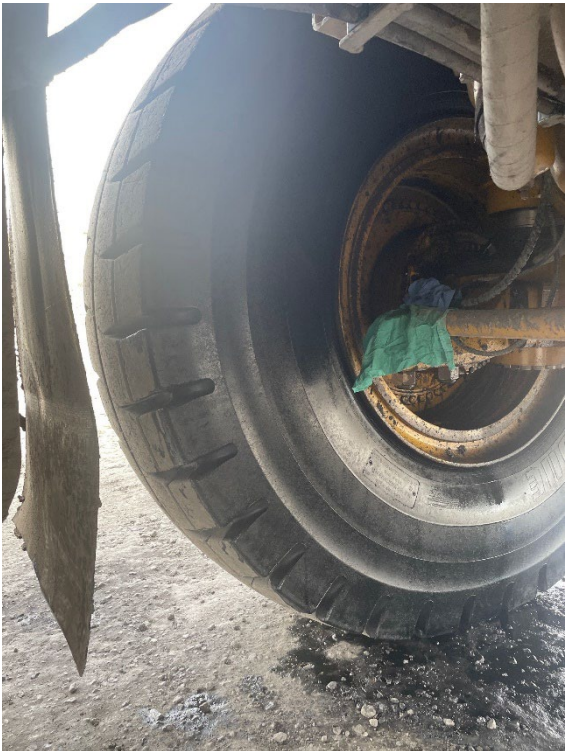
<p>Dangerous Incident</p> <p>IncNot0049665</p> <p>Surface workshop</p> <p>Leave blank</p>	<p>A worker was conducting repairs to a CAT 789D haul truck when they fell backwards from the left-hand steering tie rod, hitting their back, shoulder and head on the ground. The impact resulted in a laceration to the back of the head.</p>

<p>When conducting work at height, mine operators must ensure that hazards are identified and controls are in place to prevent a fall.</p> <p>Mine operators should consider the use of work platforms where practical to manage the risk of a fall from one level to another.</p> <p>Mine operators must ensure that appropriate information, training, instruction and supervision is provided to workers.</p>
<p>Dangerous Incident</p> <p>IncNot0049658</p> <p>Underground Metalliferous</p> <p>Fire or explosion</p>	<p>While tele-remote bogging a stope, a Sandvik 621 loader caught fire after a hydraulic hose blew, spraying oil over the engine bay. The operator noticed a large oil plume on the rear camera and, while manoeuvring the machine out of the stope, the fire suppression system activated but failed to fully extinguish the</p>	<p>Mine operators must ensure that maintenance systems include the inspection of hydraulic hoses and ensure replacement when hoses are identified as worn or cracked.</p> <p>Hoses must be routed where possible to prevent unnecessary</p>

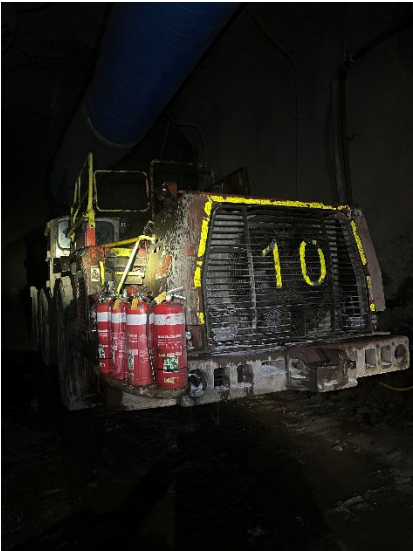
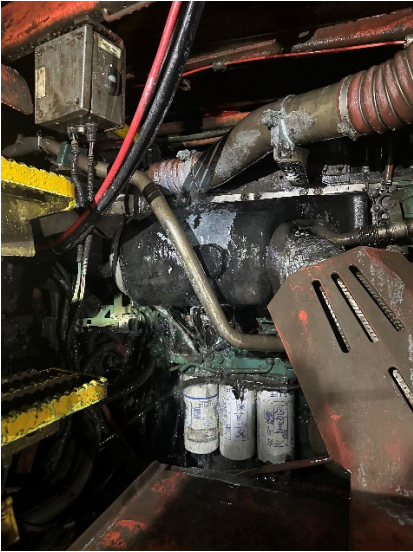
Incident type	Summary	Comm to industry
	<p>fire. As the operator approached, the fire flared, and it was eventually put out with a handheld extinguisher. Cooling continued for 30 minutes using a 2" water hose. Workers were sent to refuge chambers as a precaution, with spotters managing flare-ups. The hose, which connected the steering pump to the valve, lacked sheathing to contain the oil.</p>	<p>rubbing or damage from external sources.</p> <p>For more information refer to <u>MDG41 Guideline for fluid power safety systems at mines.</u></p>
