# Investigation information release

## Worker seriously injured by falling excavator attachment

**Event:** Worker suffers serious injuries after being hit by hydraulic hammer

# Investigation information release IIR26-01

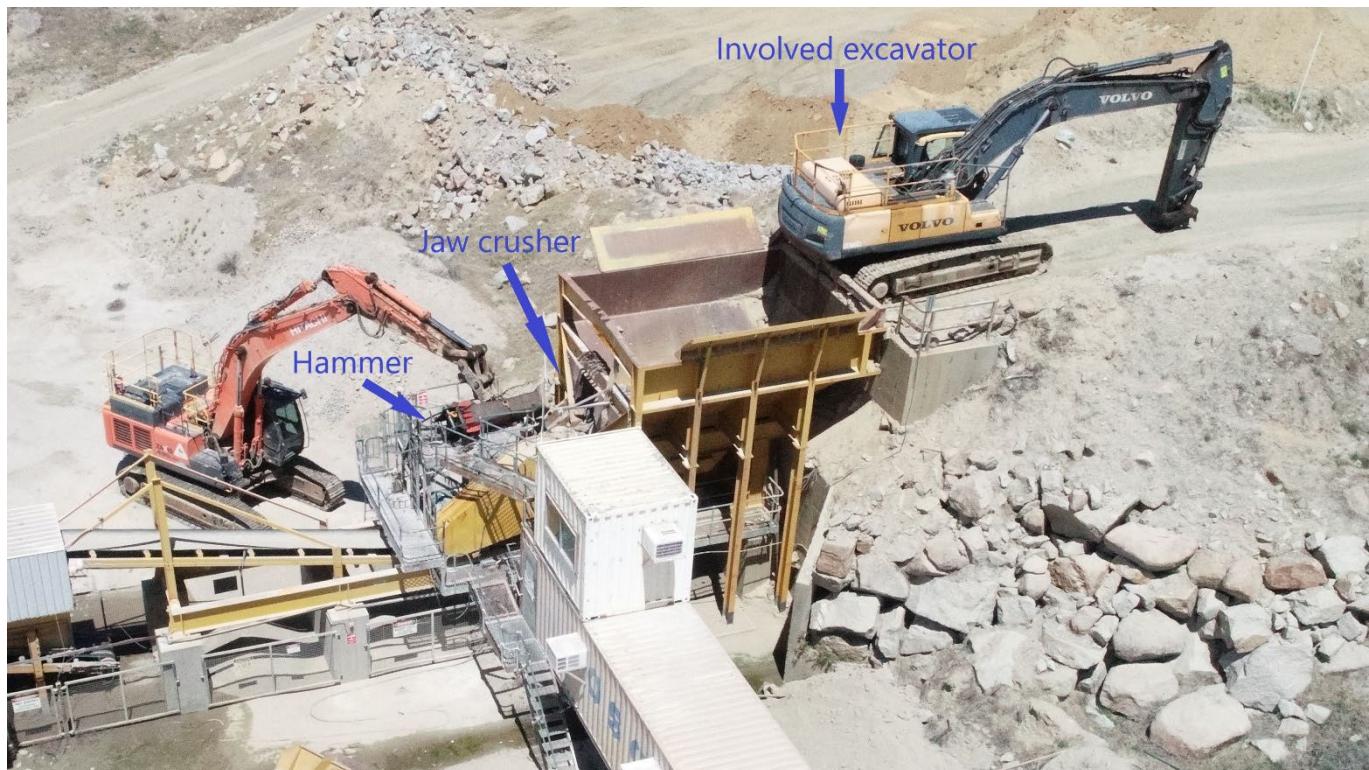
Figure 1: An overview of the incident scene (Note: following the incident, the orange-coloured excavator was moved into the area and the involved excavator was slewed around 180 degrees)

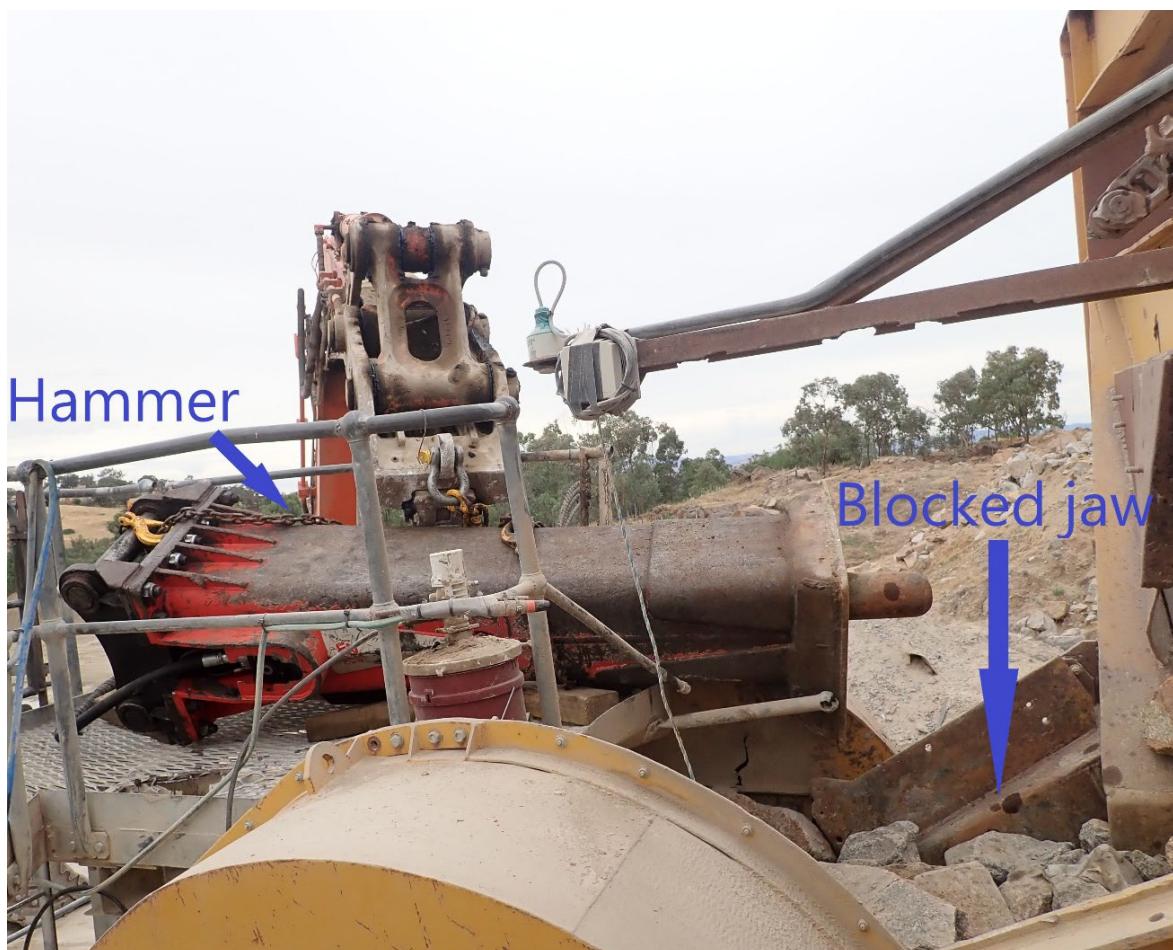
The excavator was trammed to an area above the jaw crusher, and the contract maintenance worker stood on a catwalk above the blockage to act as a spotter for the excavator operator. As the excavator operator began to position the hydraulic hammer above the blockage, the hydraulic hammer unexpectedly detached from the excavator's quick hitch device. The 3.3 tonne hammer then fell onto the contract maintenance worker, trapping and seriously injuring him.

Figure 2: The position of the hammer on the catwalk after the worker was rescued

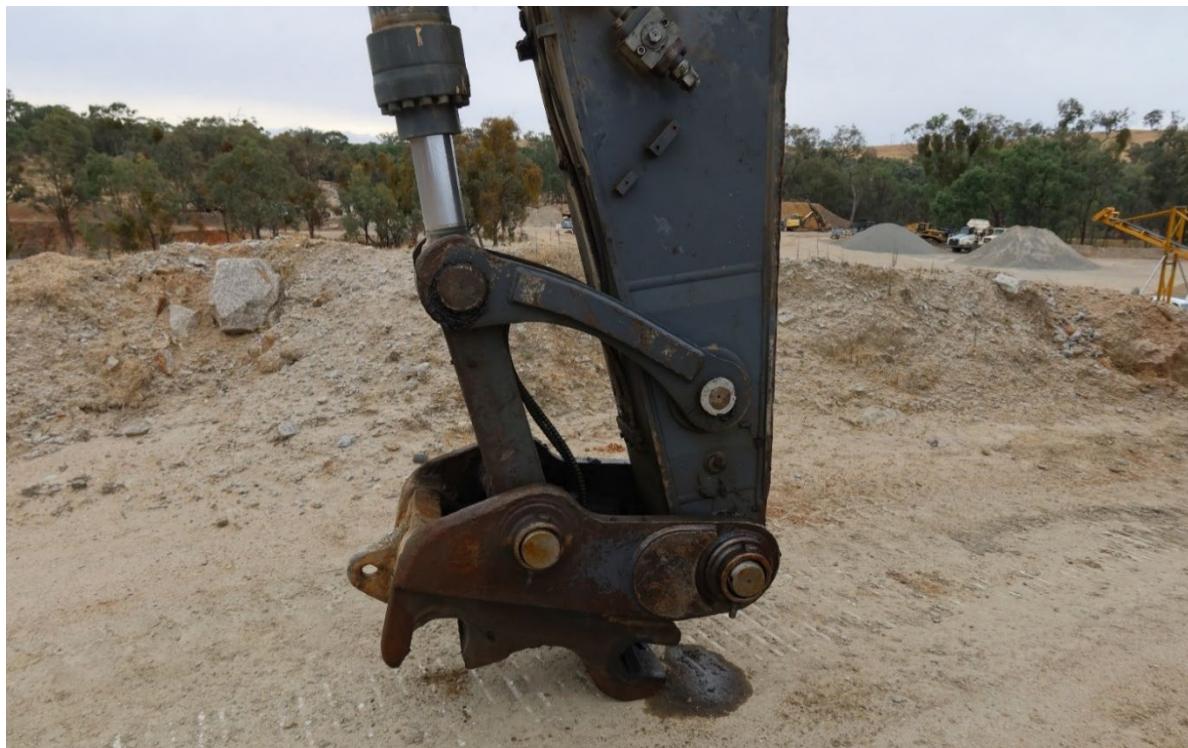
Figure 3: The quick hitch device on the excavator arm

- mechanism of failure, including whether the quick hitch device failed and/or the attachment was incorrectly installed
- condition and maintenance of plant involved in the incident
- adequacy of the quarry operators' safety management system regarding managing hazards and risks associated with mobile plant and attachments
- instruction, training and supervision of workers in relation to the work task of unblocking the jaw crusher.

- ensure that pre-start inspections are conducted each time mobile plant is used
- ensure a locking system such as a safety pin is available and required for use with quick hitch attachments
- identify and manage the risks associated with mobile plant and pedestrian interactions by implementing controls such as exclusion zones
- require the completion of an adequate risk assessment before workers commence a new work task.
