# Safety Alert

## Grader and front-end loader collide during restricted visibility

## Safety Alert SA26-03

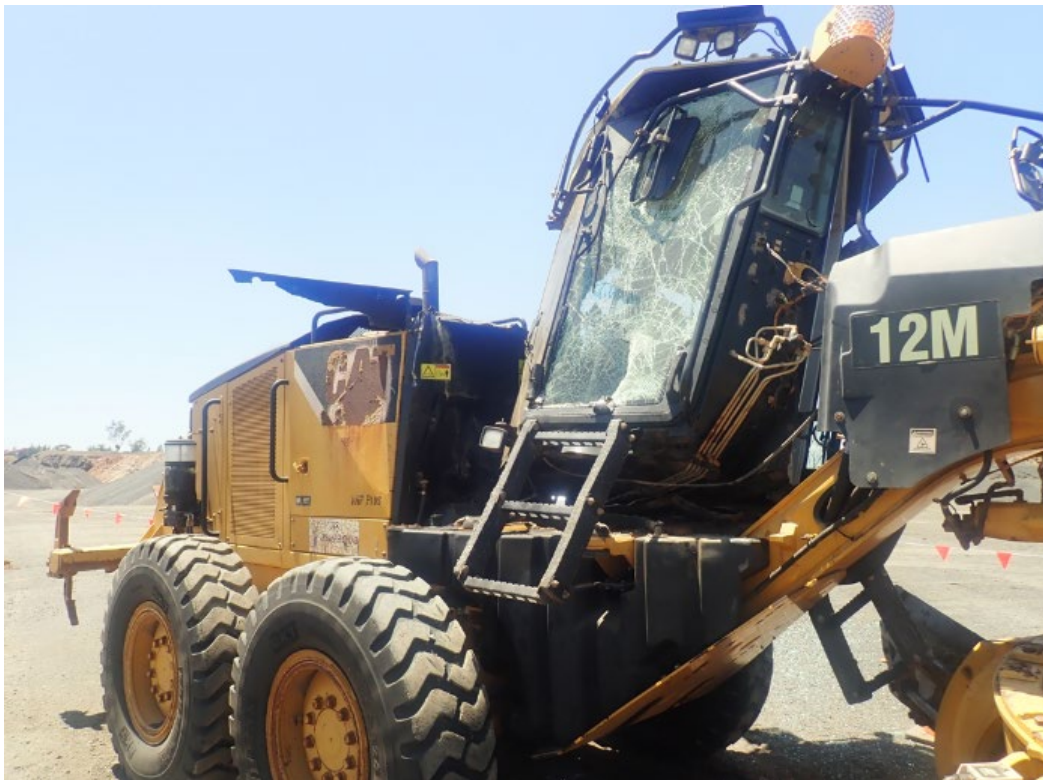
As the loader turned in front of the grader, the operator took evasive action by turning to the left. Given the unexpected action of the loader and the short time frame, a collision could not be avoided. The loader initially made contact with the grader mid-way along the main structure, before hitting the rear right cabin pillar. All grader cabin supports were severed and the cabin toppled to the left, resting on the front rear tyre.

Figure 1: The damaged grader

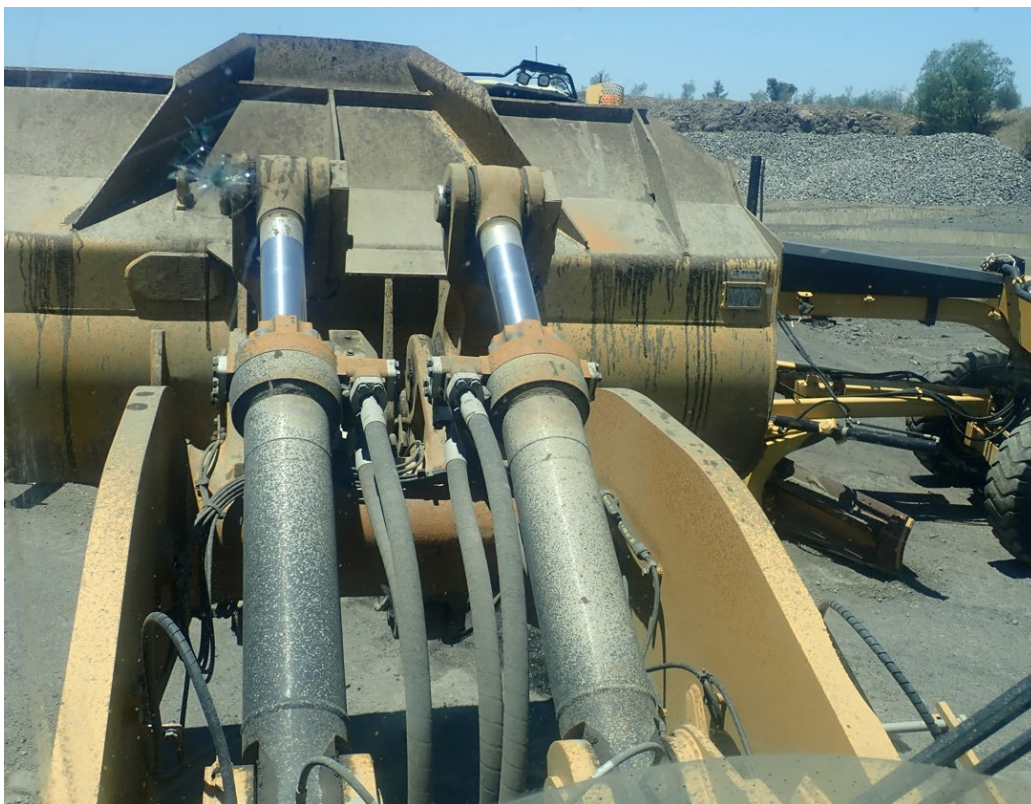
Figure 2 – Incident re-enactment photo showing obstructed view of the loader operator

- The loader operator turned across the haul road while visibility was restricted (see figure 2).
- The mine operator documented systems detailing the requirement to drive heavy mobile equipment with buckets in a lowered position.

A notice was issued to prohibit driving heavy mobile equipment with buckets in a raised position where it obstructed a driver's visibility.
