# Investigation information release

## Contract worker fatally struck by reversing mobile processing unit during blasting activities

**Location:** Open-cut coal mine near Singleton.

| Document control | |
|---|---|
| Mine safety reference | IIR26-05 |

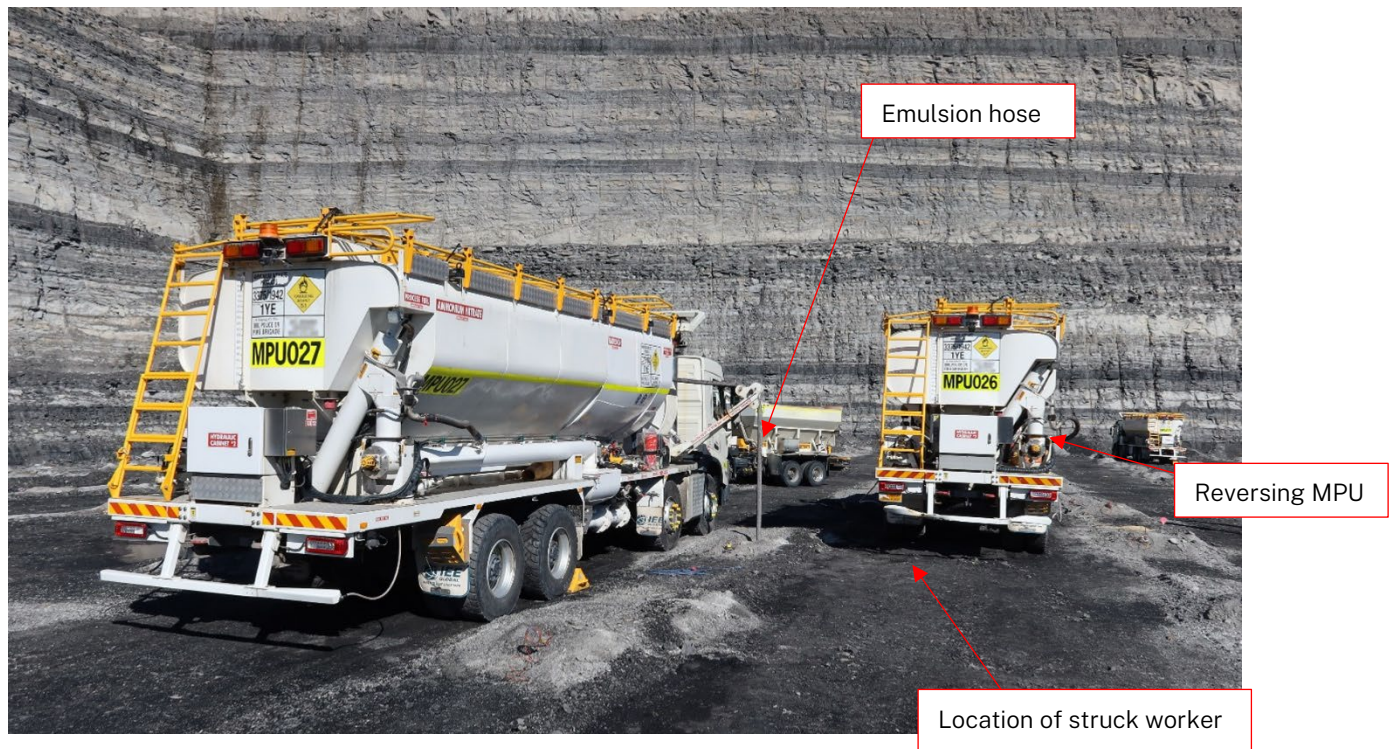
After reversing approximately 50 metres, MPU026 was adjacent to MPU027 when it struck the worker who suffered fatal injuries.

Figure 1 The 2 mobile processing units following the incident

- Provide workers with appropriate instruction and supervision to ensure effective positive communications are maintained by operators and pedestrians
- Ensure that spotters are effectively used to assist reversing mobile plant
- Consider and, where reasonably practicable, incorporate the use of available technology to control mobile plant and pedestrian interactions such as proximity detection and collision avoidance systems
- Consider the potential for mobile plant and pedestrian interactions when designing and sequencing work on drill patterns, including the loading of explosives, and develop effective controls to maintain separation
- Ensure that the risk controls for mobile plant and pedestrian interactions are being adequately monitored and verified by safety management system review and auditing mechanisms
