# Weekly incident summary

## Week ending 11 September 2026

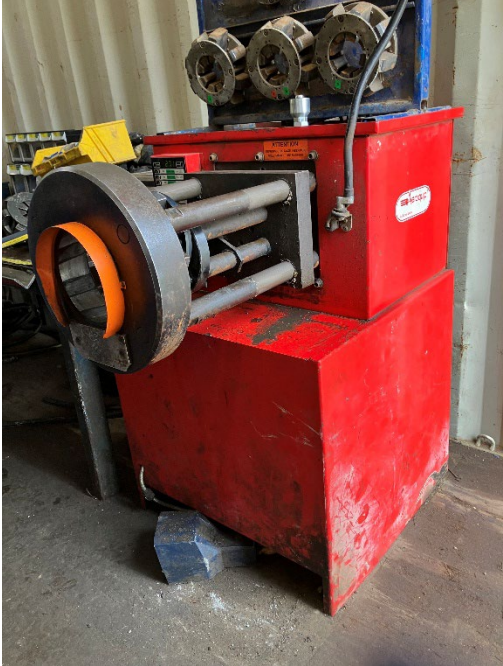
| Incident type | Summary | Recommendations to industry |
|---|---|---|
| <p>Dangerous incident<br/>IncNot0052005<br/>Underground metals mine</p> | <p>A fitter was changing a die in a hydraulic hose crimping press. While undertaking the work while the machine was operational, he inadvertently activated the foot pedal which crushed his fingers in the press, resulting in significant hand and finger injuries.</p> | <p>Mine workers must ensure machinery that can cause crushing injuries is switched off and isolated prior to undertaking maintenance work.</p> <p>Mine operators must ensure:</p> <ul style="list-style-type: none"> <li>workers are trained and competent before undertaking work tasks, including the isolation procedures for plant they are working on.</li> <li>an introduction to site process is implemented when bringing plant to site and suitable procedures are developed for operation and maintenance activities to control hazards and prevent incidents.</li> </ul> |

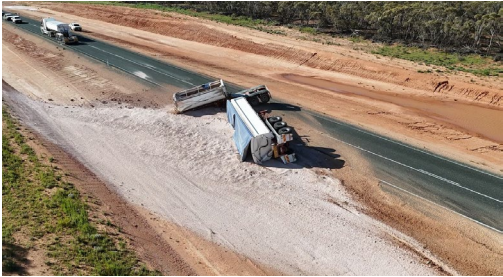
| Incident type | Summary | Recommendations to industry |
|---|---|---|
| <p>Dangerous incident<br/>IncNot0052009<br/>Surface extractives mine<br/>Roads or other vehicle operating areas</p> | <p>A B-triple truck delivering limestone sand to site was involved in a single-vehicle rollover incident on the main access road into the mine. While travelling at approximately 80 km/h, the rear two trailers rolled onto their side and separated from the lead trailer and prime mover. No other vehicles were involved.</p> <p>Preliminary information suggests the incident may have been caused by trailer sway, with wind conditions and</p> | <p>Mine operators should review the layered defence model described in the <a href="#">Technical reference guide: Roads and other vehicle operating areas</a> when designing their material supply and handling systems.</p> <ul style="list-style-type: none"> <li>Layer 1 focuses on site requirements including standards and mine roadway design. The mine ROVOA PHMP should provide adequate risk reduction by identifying and mitigating hazards and risks associated with design and maintenance of road surfaces.</li> </ul> |

| Incident type | Summary | Recommendations to industry |
|---|---|---|
| | <p>soft road edges being considered a potential contributing factor. The prime mover and front trailer remained upright, while the second and third trailers overturned adjacent to the roadway.</p> | <ul style="list-style-type: none"><li>Layer 7 focuses on operator awareness. This layer aims to introduce technologies that provide information to enhance the ability to comprehend the immediate environment and understand potential hazards in the vicinity.</li></ul> |
