SAFETY ALERT

FIELD TECHNICIANS INJURED AT DRILLING SITE

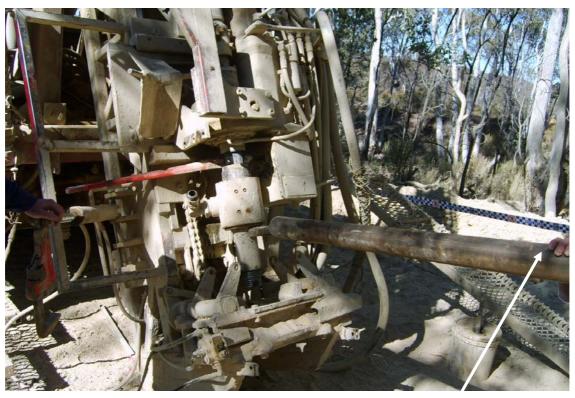
Drill Rig with Drill Rod Being Used as a Lever

The driller and his assistant had attempted to crack the thread on the air swivel without success. It was decided to use a 3 metre long drill rod as a lever to try and crack the frozen thread. Two field technicians who were working nearby were asked to assist hold the drill rod in position. The lever was positioned over a set of large stilsons below the frozen thread. Another set of large stilsons

were positioned above the frozen thread. *Refer photograph page 1*. The drill rig was started and forward rotation applied to hold the top set of stilsons in place. The forward rotation force was released resulting in the drill rod immediately moving in the reverse direction. The two field technicians were struck on the head by the drill rod, knocking them to the ground. They both sustained head injuries. The driller's assistant was also knocked to the ground by the drill rod, he was uninjured.

- Lever used without first applying risk management principles and the hierarchy of controls
- Drill rig started while persons were at risk
- The drilling contractor's safety management plan included isolation and Job Safety Analysis (JSA) / risk assessment programs. The JSA and risk assessment programs were not effectively implemented

- 1. Developing and implementing effective isolation procedures to control exposure to hazardous energies
- 2. Providing information and training to ensure persons are competent to carry out their work activities
- 3. Ensuring contractors safety management plans are approved, regularly reviewed and are effectively implemented
- 4. Ensure equipment is fit for purpose
- 5. Conduct JSA or risk assessment for all non routine high risk work activities apply the hierarchy of controls
- Refer and review Minerals Industry Safety Handbook Section 4.2.7 Exploration Drilling
