SAFETY BULLETIN

Lack of bunding on accessible edges

Open edges on stockpiles, tip heads, ramps and dams

CM9 reference	DOC19/622387
Mine safety reference	SB19 - 07
Date published	14 August 2019
Authorised by	Chief Inspector Office of the Chief Inspector

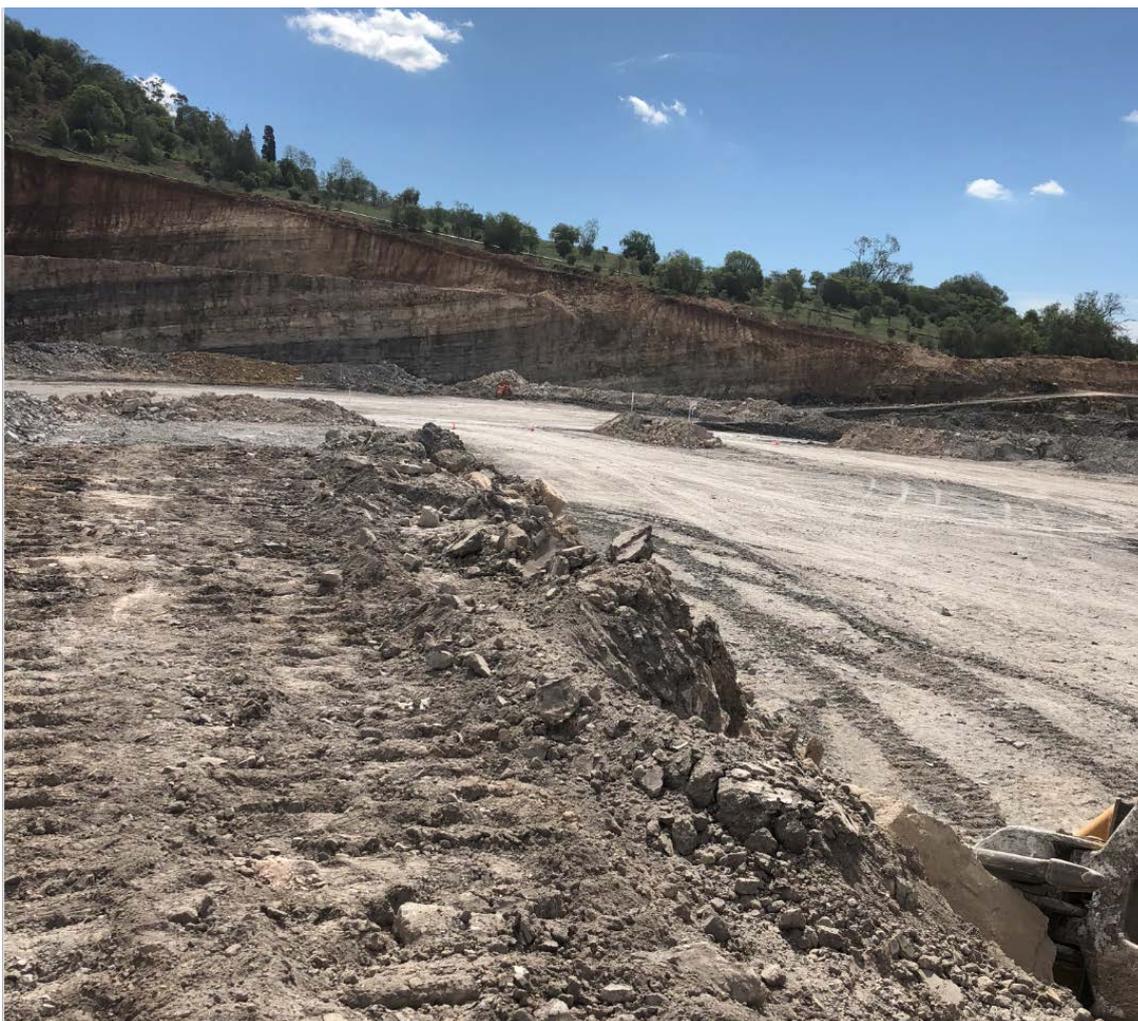
Figure 1 An example of a ramp up to a bench with an open edge with insufficient controls in place to protect workers from exposure of driving earthmoving machinery off from a height.

1. Review windrow and bunding requirements specified in the principal hazard management plan for roads and other vehicle operating areas.
2. Ensure appropriately designed, constructed and maintained bunds are in place on ramps, benches and dumps.
3. Ensure ramp edges are adequately bunded to reduce the risk of falls and edge failure.
4. Conduct regular workplace inspections to identify fall hazards, including inspection of stockpiles, tip heads and dams for open and accessible edges.

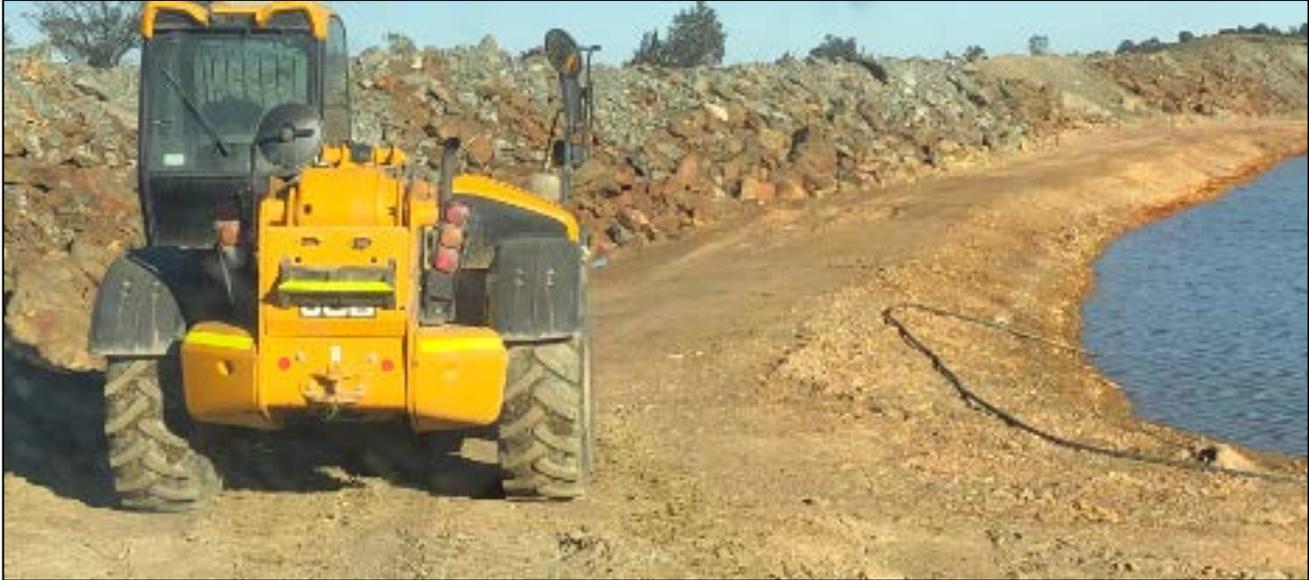
Figure 2 An example of an access road with an open edge, with insufficient controls in place to protect workers from exposure of driving into the open body of water.
