NSW Resources Regulator

COMPLIANCE AUDIT PROGRAM
DECLARED SYDNEY CATCHMENT SPECIAL AREAS

Management of mining infrastructure in Special

Summary Report

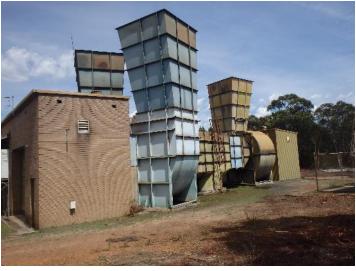
Example of a ventilation shaft site within the Special Area

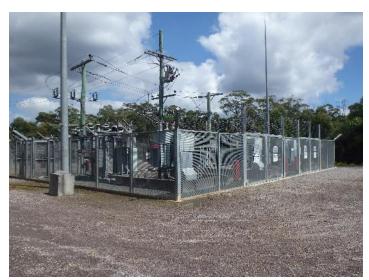
Example of a transformer yard associated with a large vent shaft site in the Special Area

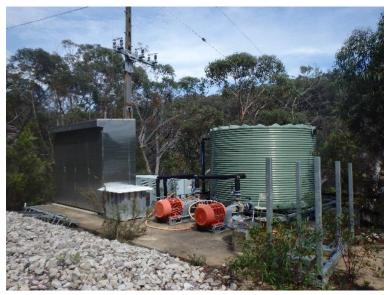
Example of a pump station site adjacent to Cataract Dam

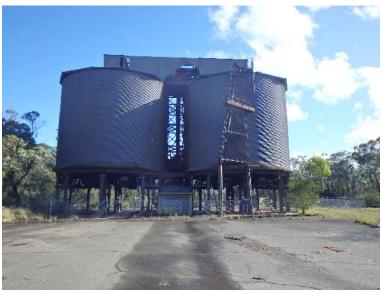
Example of coal loading bins in the Special Area

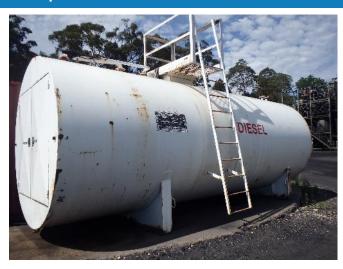
✓ Roofed bunded refuelling facility with provision for small packaged goods within the bunded area – note the yellow spill kit bin adjacent to the refuelling bowsers.

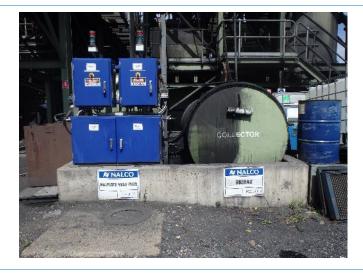
Poor storage practice - drums of fuels and oils with no spill protection in a workshop.

For bunding to be effective in providing secondary containment, all containers must be located inside of the bunded facility. For smaller packaged materials, bunded spill pallets or hazardous goods cabinets may provide a suitable alternative for sites such as workshops where small quantities of chemicals, oils and greases are used often.

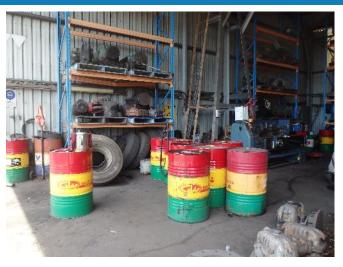
Poor storage practice - drums of chemicals sitting on a bund wall where containment may not be provided if a leak or spill occurred.

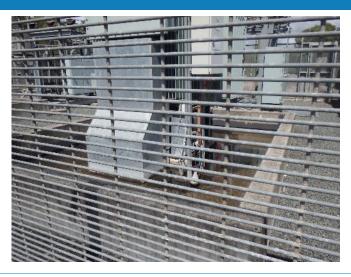
Transformers at an operating ventilation shaft site contained within a concrete bund which would provide containment in the event of a leak or spill.

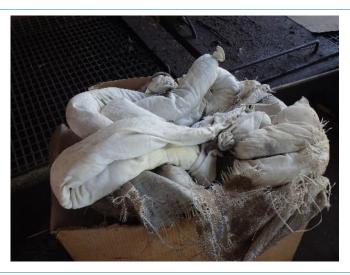
Absorbent spill control socks and booms at a remote operational vent shaft site not maintained in a ready state.
