Investigation report

Serious injury of a worker at Thuddungra Mine

May 2023

Subtitle: Investigation Report into the serious injury of a worker at Thuddungra Mine on 10 August 2021

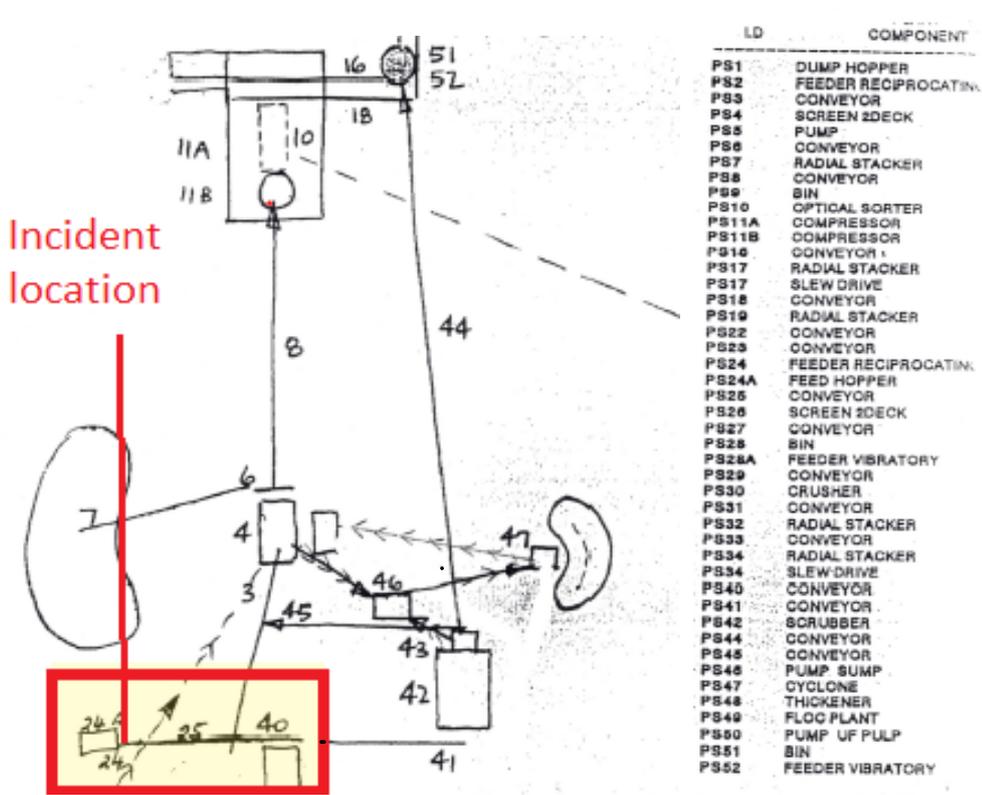
Figure 2 - Excerpt from mine operator’s conveyor layout diagram showing the location of the PS25 conveyor

The incident occurred at the PS25 conveyor at the southern end of the mine’s photometric plant. The plant is controlled from a panel in a control room about 75 metres from the hopper.

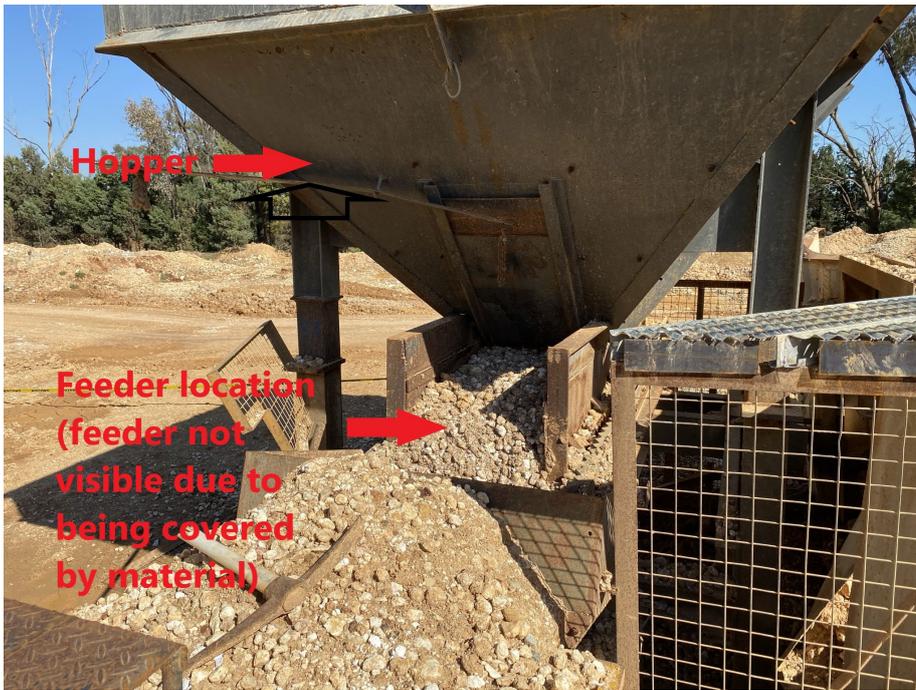
Figure 3- Hopper and feeder locations

The conveyor was the first in a series of conveyors at the mine that moved mined product through the plant's processing machinery. A Caterpillar 966 front end loader was used to feed product into the PS24A feed hopper above the conveyor. The PS24 reciprocating plate feeder was beneath the hopper. It consisted of a motorised plate that moved back and forth shuffling product from the hopper into the conveyor chute. The mine operator stated that the hopper was fabricated in 2020. The conveyor and feeder were installed between 1998 and 2005. The mine operator was unable to provide any evidence of risk assessments undertaken in respect to the design of the hopper, conveyor or chute.
