## Investigation report

# Near collision between haul truck and light vehicle at Maules Creek Mine

*June 2023*

**Published by the Department of Regional NSW**

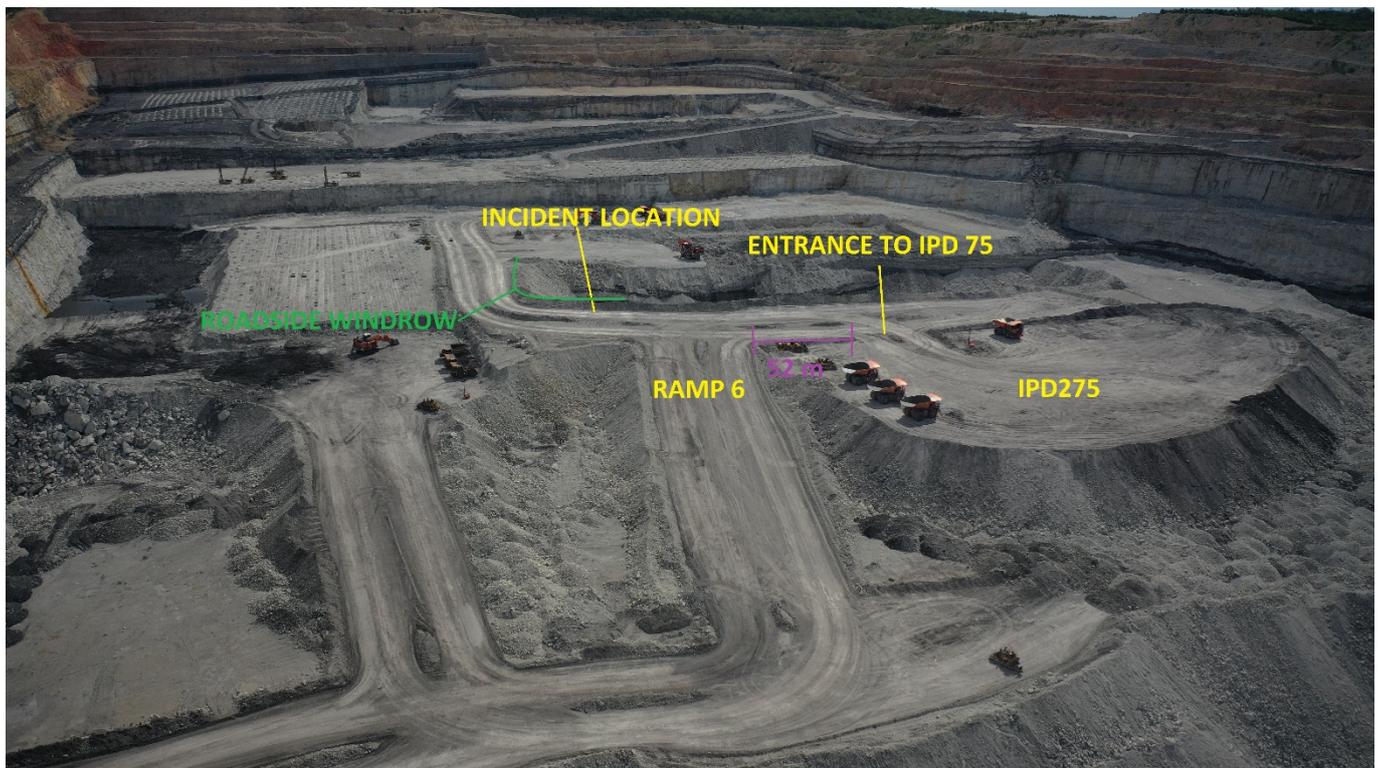
Figure 1 - Overview of incident location

The intersection was opened on 16 November 2022. The adjacent intersection at the entrance to IPD275 was opened on 1 December 2022. The distance between these 2 intersections was 52.7 metres.

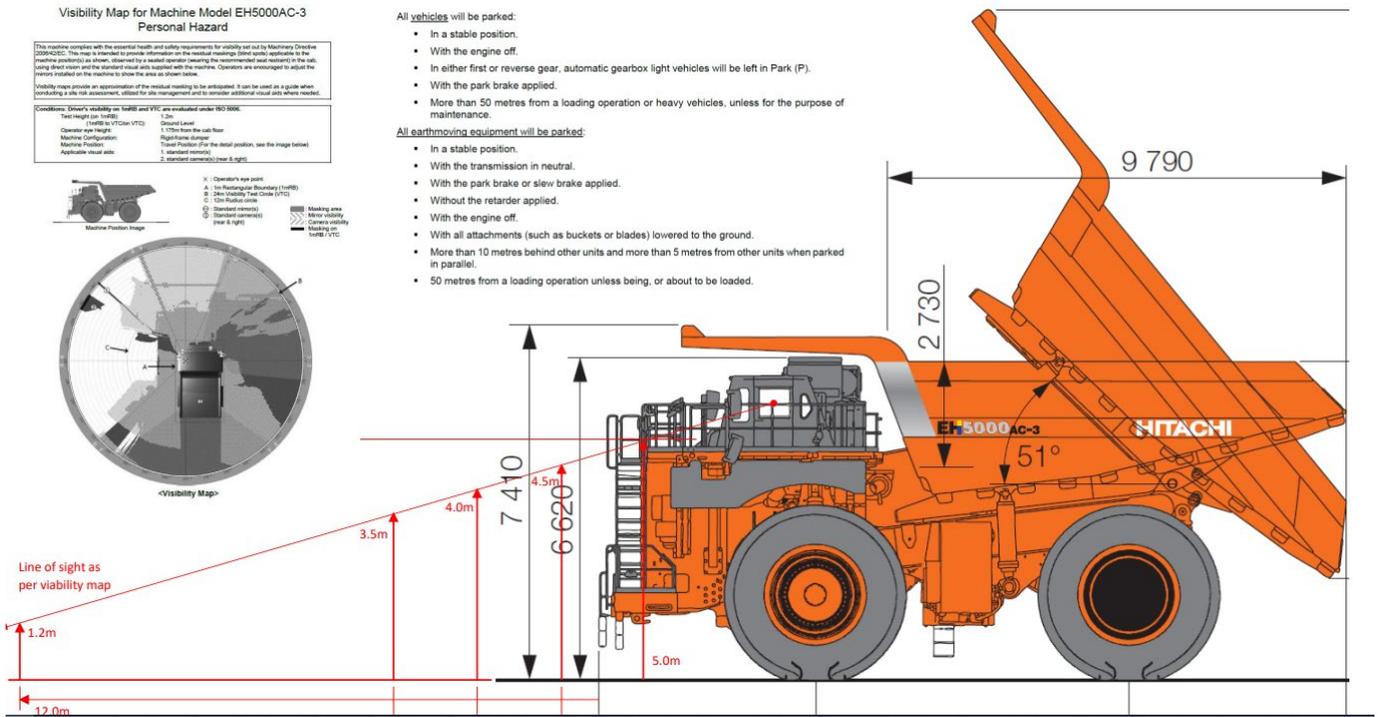
Figure 21 - Visibility from an EH5000 truck

The light vehicle was fully obstructed from the Caterpillar truck operator's view by the pillar of the truck cabin and instrumentation mounted to it. Had the Caterpillar truck been positioned further forward, the operator's field of view would have been different. It is unclear if this would have made the light vehicle more visible to the Caterpillar truck operator.

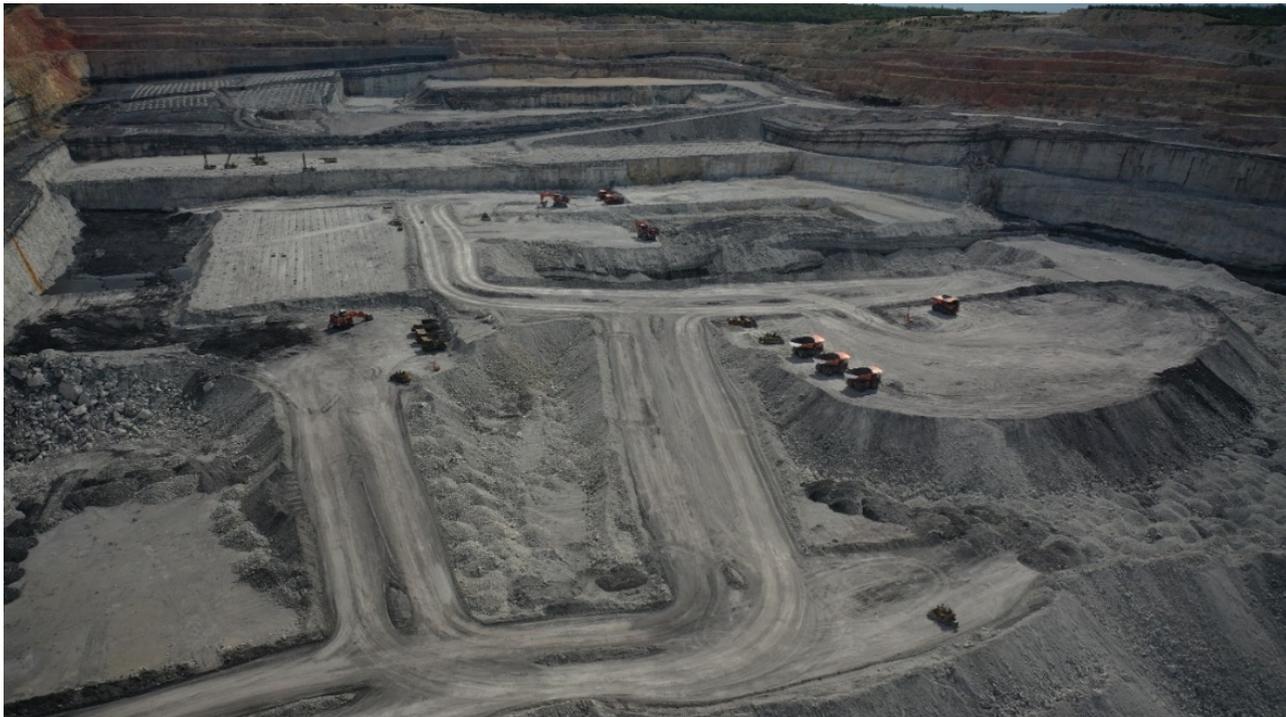
Figure 24 - Incident area

As Figure 26 shows, the mining activity that was occurring adjacent to the intersection, the preceding bend and IPD275 meant that there were very few options about where a road could be built. However, increasing the radius of the inside curve of the bend, or opening up the angle of approach to the intersection, would have created a more open curved approach and improved the line of sight to the intersection thereby increasing the sight distance of vehicle operators.

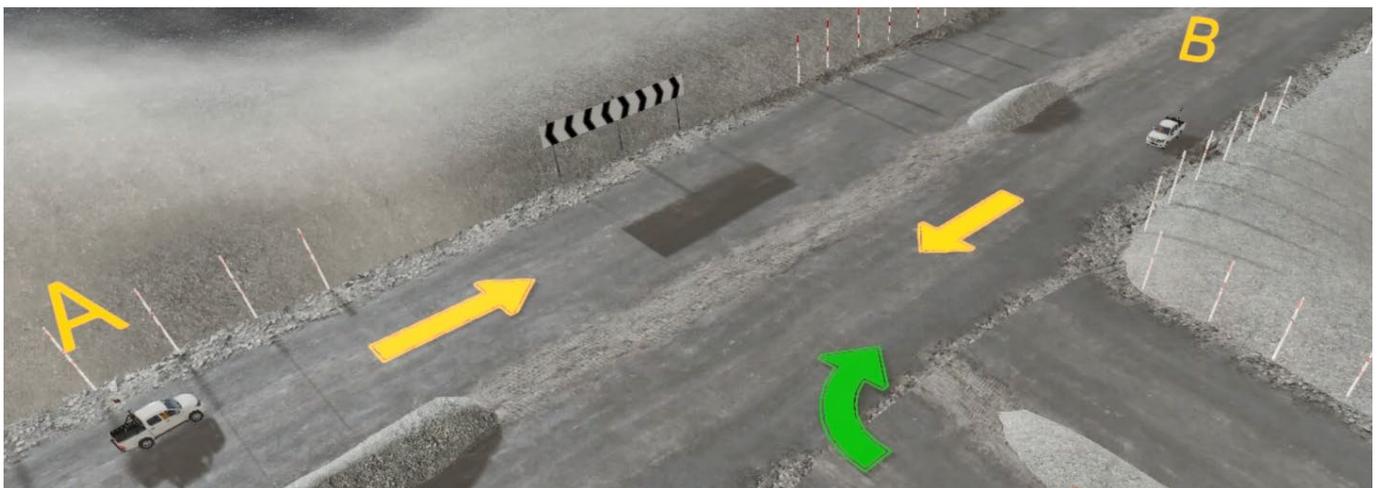
There was no documented information at the mine about where light and heavy vehicles should be positioned when stopping to give way at intersections. The mine operator stated some information about where to stop at intersections was given to operators in videos and slides provided to operators as part of the hierarchy training. However, some of the material in some of these videos and slides supports the decisions of the light vehicle and Caterpillar truck operators to stop back from the intersection. This material depicts light and heavy vehicles stopped some distance back from intersections.

Figure 26 - Training animation showing light vehicle stopped 10 metres from an intersection and in the left part of the lane (each pole is 5 metres)

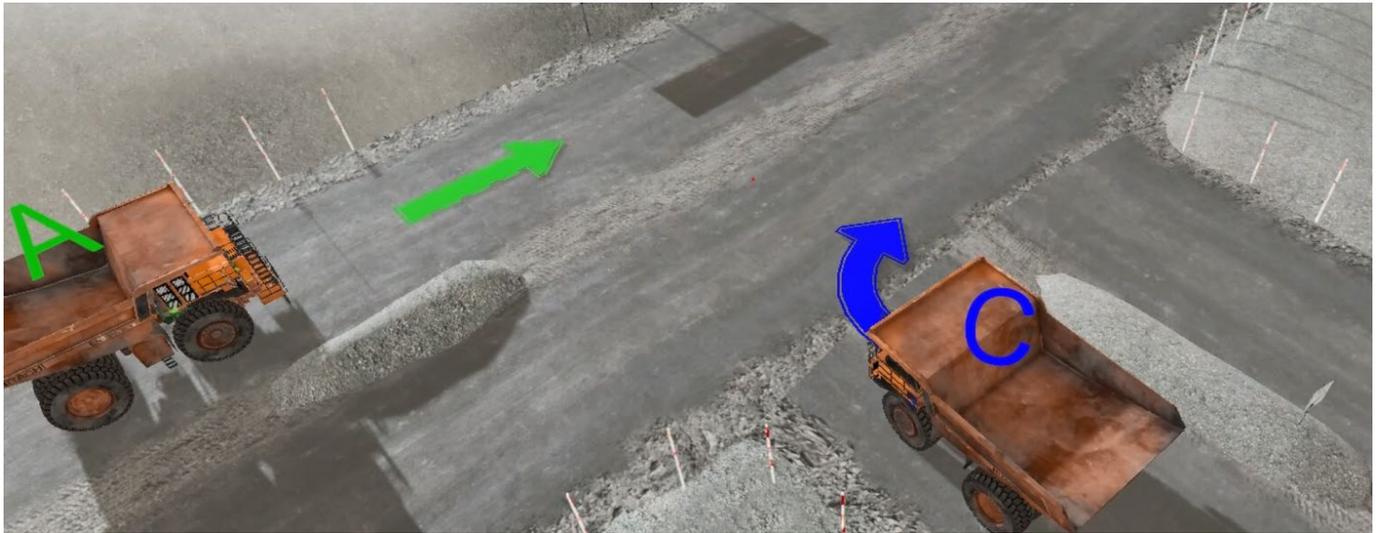
Figure 28- Training animation showing heavy vehicle A stopped about 8 metres from an intersection
