Lessons learned – Requires comprehensive investigations

Small Mines Roadshow 2025

Review of 3 dangerous incidents (Section 190) investigated by the Resources Regulator

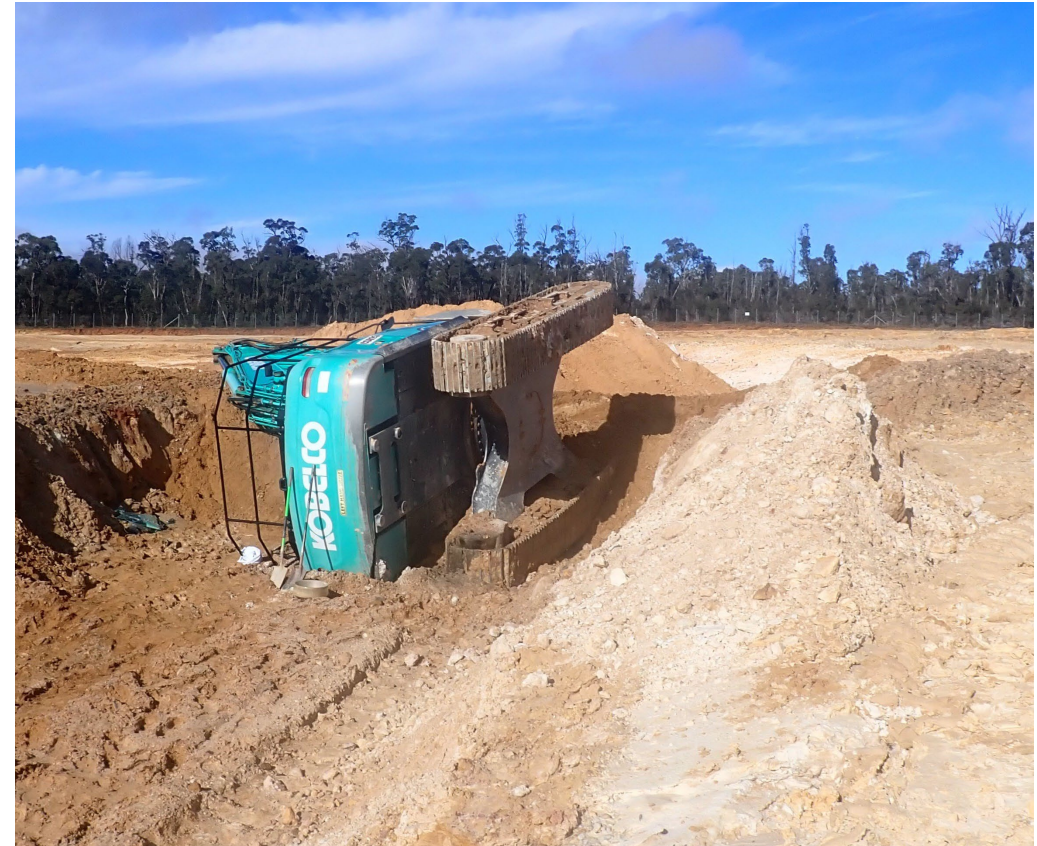
S 190 (2) (d) the unintended overturning of a vehicle or of plant weighing more than 1,000kg

- Safe Work Method Statement (SWMS) available.
- SWMS required inspection of work area for the task prior to commencing activities.
- Bunding standards were established.

- Operators trained under a VoC process.
- Fit for purpose equipment
- Excavator had a reversing camera and reverse lighting.

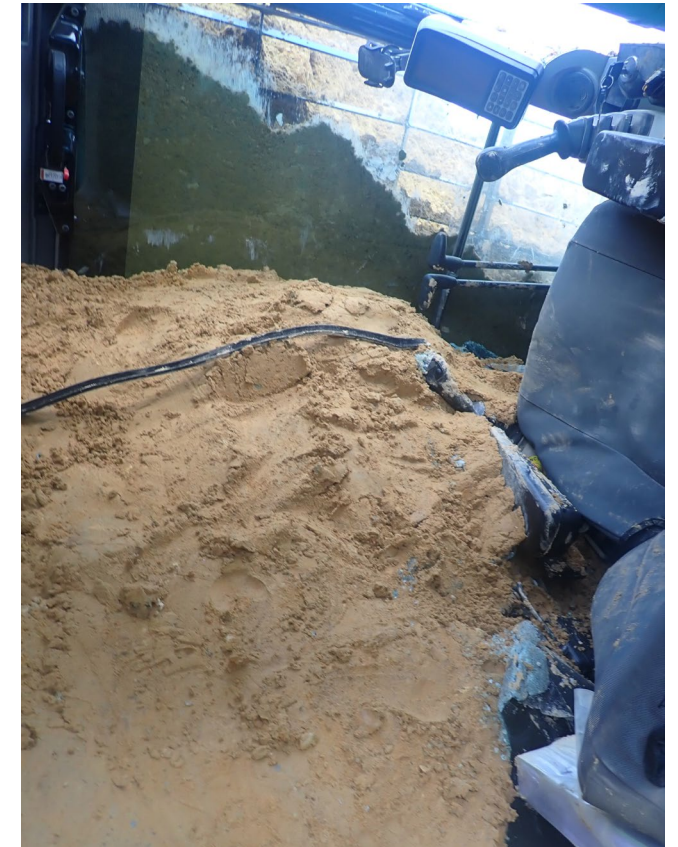
S 190 (2) (d) the unintended overturning of a vehicle or of plant weighing more than 1,000kg,

- Emergency plan initiated and emergency services contacted.

- Seat belts available and mandatory to be worn.
- Fire extinguishers on board and water truck cannon available in case of fire.
- Emergency stop device and isolation key on excavator.
- Cabin structural integrity (TOPS & ROPs)

- Fitness for work policy implemented.
- First aiders and first aid equipment available.

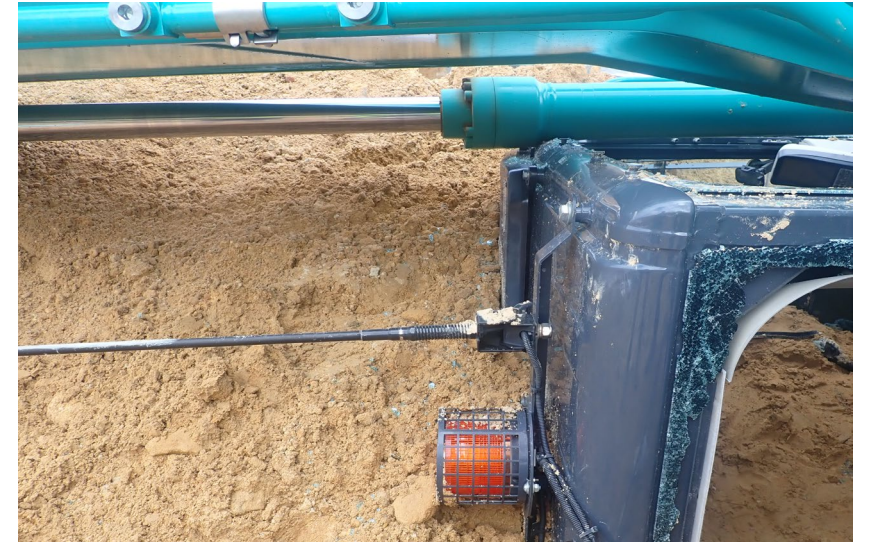
S 190 (2) (d) the unintended overturning of a vehicle or of plant weighing more than 1,000kg,

- SWMS, ROVOA and MECP reviewed to implement additional controls.
- SLAM booklet implemented. (Stop, Look, Assess, Manage).
- Conduct JSA prior to standing excavator back-up in consultation with workers.
- Review and evaluate emergency plan with respect to the incident in consultation with workers. (debrief)

- Extra LED lights added to the side and rear of the excavator in consultation with operators and existing lighting replaced with LED lighting.

- Use lighting tower when operating in darkness. (also, a SWPractice)

- Reinforce to workers and supervisors that bunds are to be built to correct standards along exposed edges.

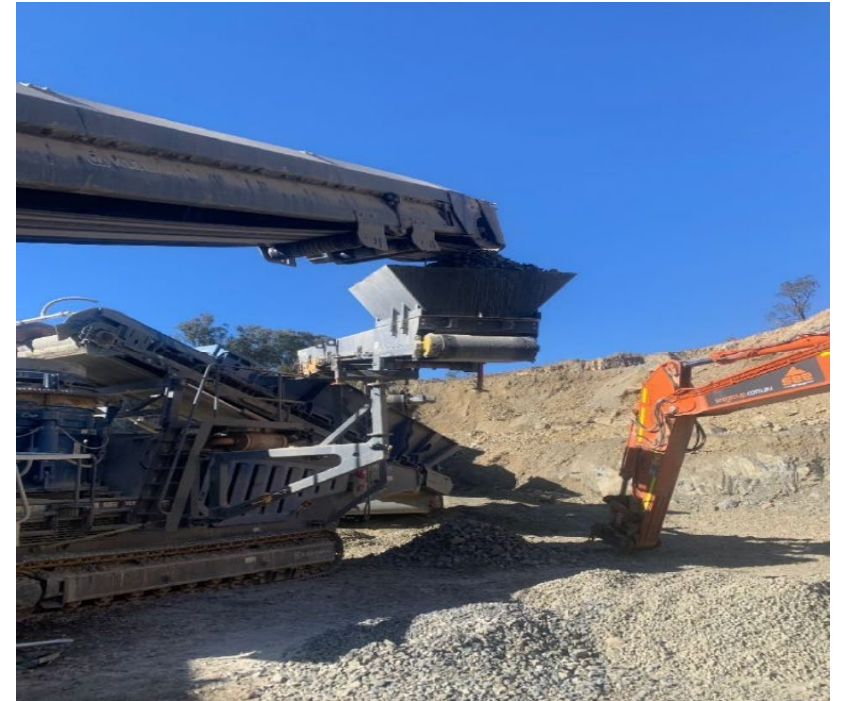
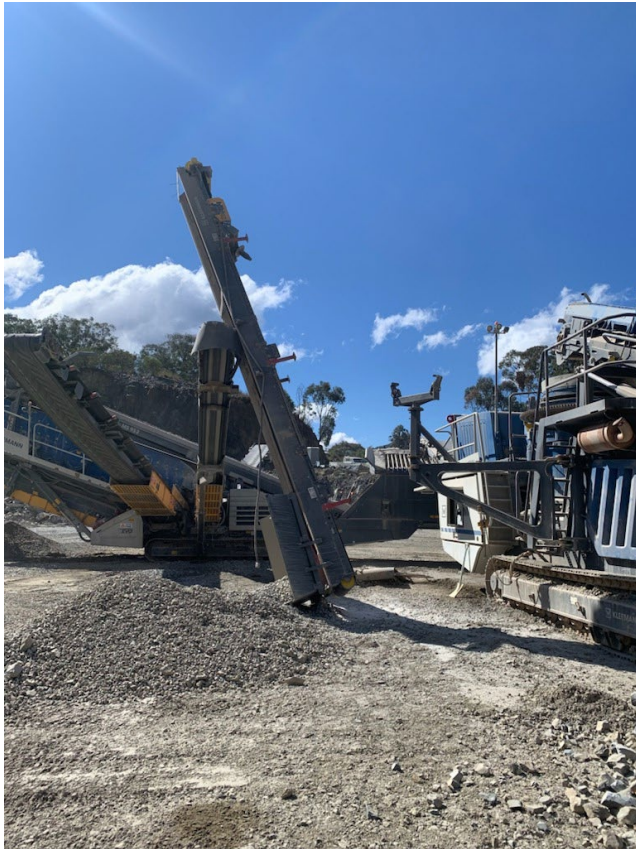
S 190 (1) (e) the fall or release from a height of plant, a substance or a thing, or

(1) (g) the collapse or partial collapse of a structure.

- Missing bolts not identified when commissioning plant.

- No structural design considerations for the hopper.
- Abnormal setup required the conveyor to be extended, leading to over-balancing the conveyor when the new feed hopper was full.
- A bigger feed hopper caused increased material weight on cantilevered section of the conveyor.

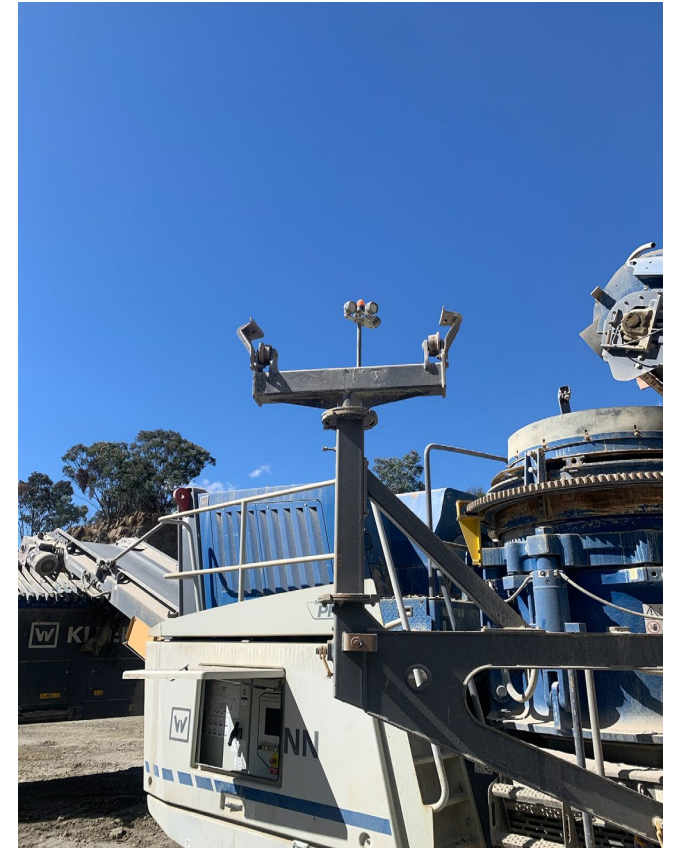
- Training did not specifically address the correct process for installation and setup of equipment prior to operation as described by the OEM.
- Workers did not identify missing bolts were required for the mounting flange during assembly, to prevent the conveyor belt lifting out, as specified in the OEM manual.
- Reliance on worker experience rather than set procedures for commissioning the plant once set-up.

- Conduct structural audit of all plant at the site.
- Review MECP and associated risk assessment regarding incident outcomes, including design principles, engineering and technical standards for plant modifications.

- Plant OEM training for workers to ensuring equipment is installed correctly.
- Toolbox workers on incident findings and actions.
- Environment
- Unknown?

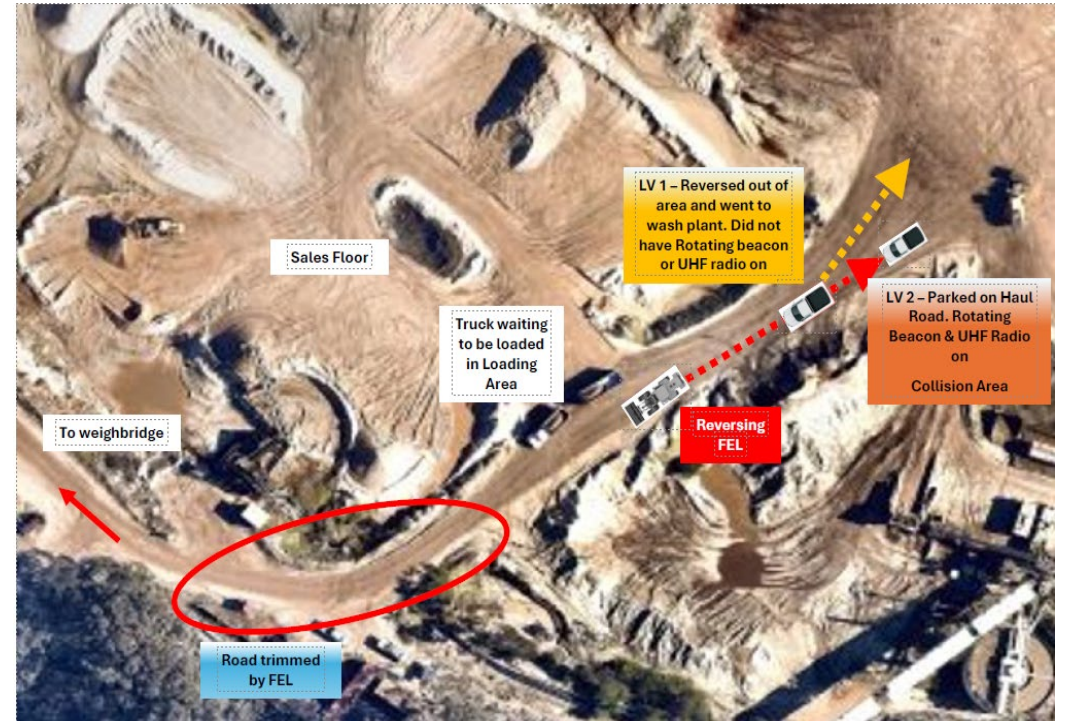
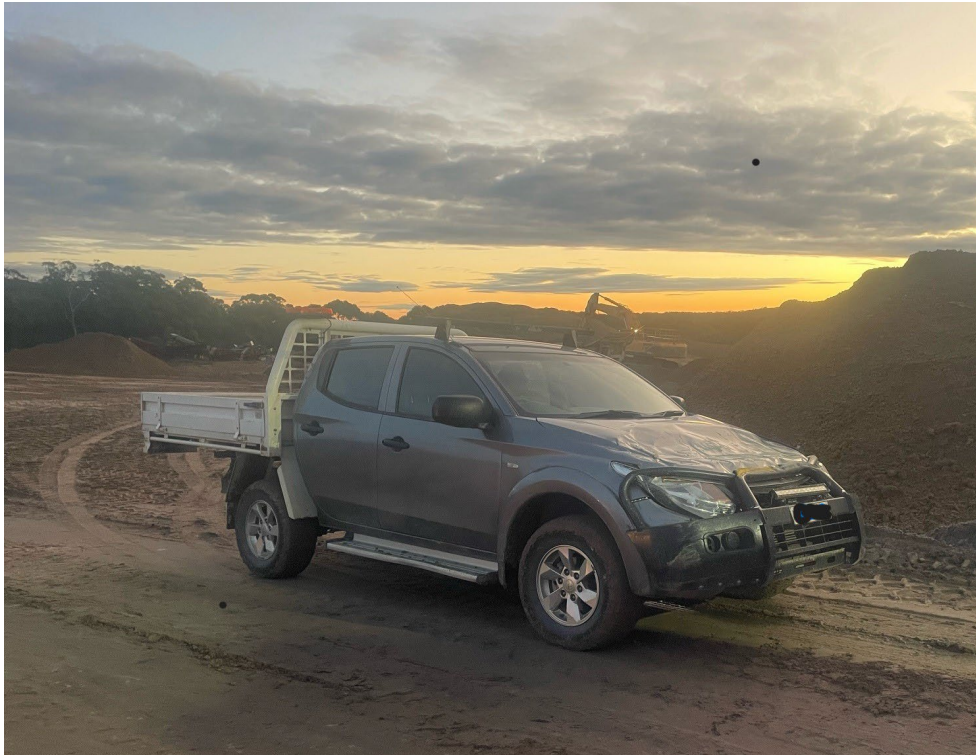
S 190 (1) (m) a collision involving a vehicle or mobile plant

- Wide roadways to minimised plant collisions.

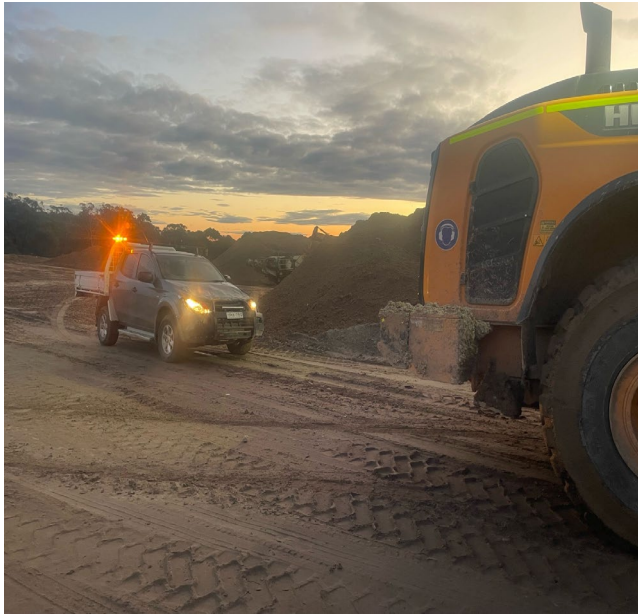
S 190 (1) (m) a collision involving a vehicle or mobile plant

- Fitter failed to let the coworker/supervisor know that his radio was not working.
- Loader operator did not take sufficient care when reversing in the dark.

- Loader OEM contacted regarding retrofitting detection/rear proximity sensors.

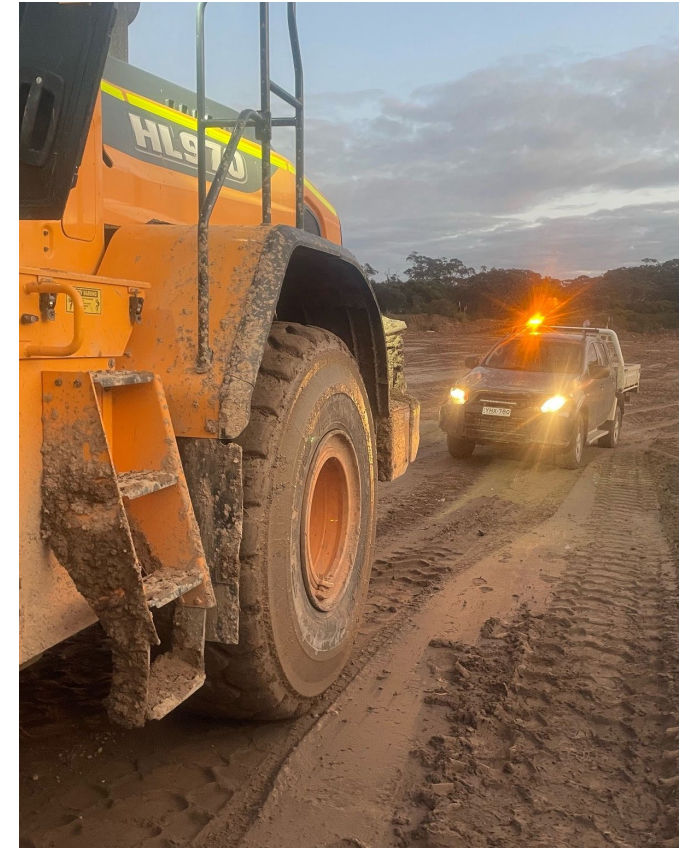
S 190 (1) (m) a collision involving a vehicle or mobile plant

- Refresher training for workers regarding site communication protocols.
- Refresher training for loader operators to look for potential hazards before moving/reversing.
- Refresher training (toolbox) regarding contacting supervisor and coworker by mobile phone if UHF radio is not working.

- Increase the number of dedicated LV parking areas around the site.
