Weekly incident summary

Week ending 20 June 2025

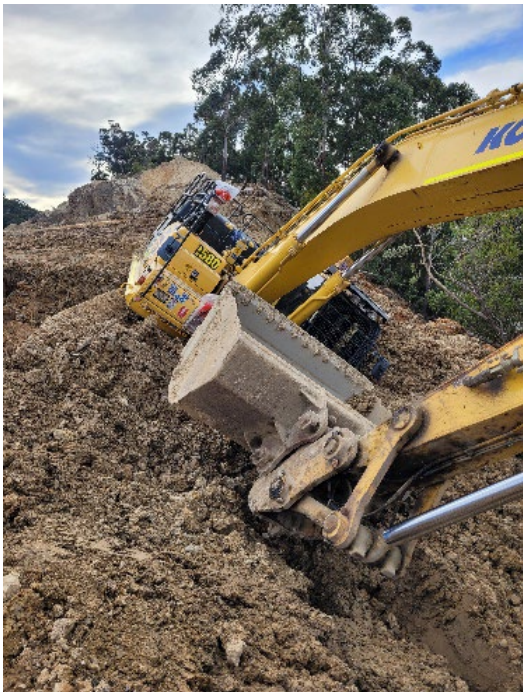
Incident type	Summary	Comments to industry
 	<p>The SMV operator failed to see the stored roof support.</p>  	
<p>Dangerous incident IncNot0049308 Construction materials Roads or other vehicle operating areas</p>  	<p>An excavator operating in a weathered zone became bogged and the machine slid about 3 metres.</p> <p>The operator was working on saturated overburden when the machine bogged.</p> <p>The operator slewed the excavator, and the counterweight went over the downward slope causing the track to sink further.</p>

<p>Ground stability should be a primary consideration when working on overburden. Material consistency, wet conditions and dipping ground should be considered.</p> <p>Inspections should verify ground integrity and areas that do not meet the standard should be demarcated, communicated and remediated to meet the standard.</p> <p>When operating machinery, workers' primary focus must remain on the operation and control of the plant or vehicle. Mine operators should review the triggers for competency assessment and the minimum level of competence required before workers are authorised for solo operations.</p>
