# Weekly incident summary

## Week ending 30 May 2025

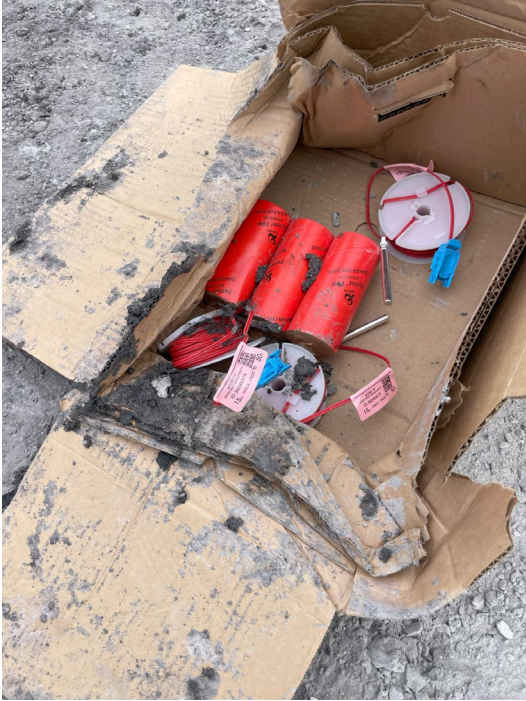
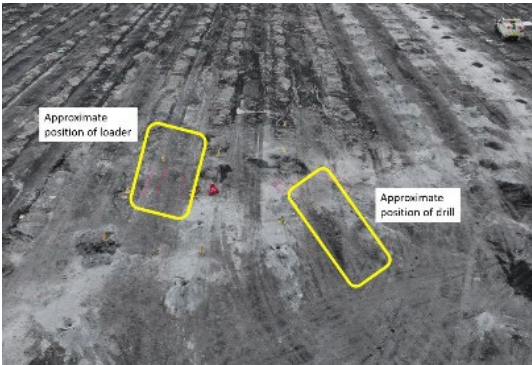
<p>A loader inadvertently ran over and damaged 2 boosters that were on the ground while exiting a shot pattern.</p>

</div>	will not be in the vicinity during these tasks.
