Weekly incident summary

Week ending 6 June 2025

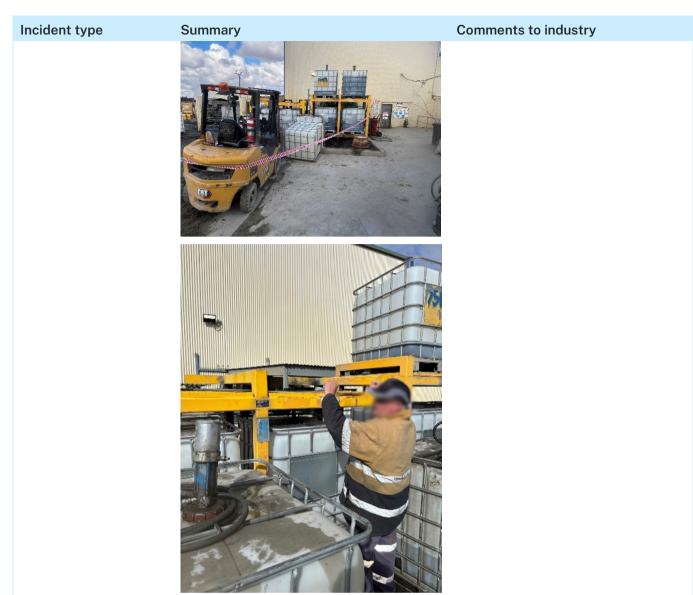
A maintenance trades assistant was trying to replace an empty oil pod from the top of an oil rack.

As the assistant pulled the pod forward, he was not aware the pod still contained about 70 litres of oil. The momentum of the oil in the pod caused the pod to topple off the rack and hit the assistant, causing minor injuries. The pod hit another 2 pods on the way to the ground, shielding the assistant to a degree, before coming to rest on the ground.

Site procedures are developed to help protect workers from injury or illness. Where a procedure exists for a particular task, workers should follow the procedure. Any deviation from a procedure should be discussed first with a supervisor and appropriate risk control measures put in place.
