# Weekly incident summary

## Week ending 4 July 2025

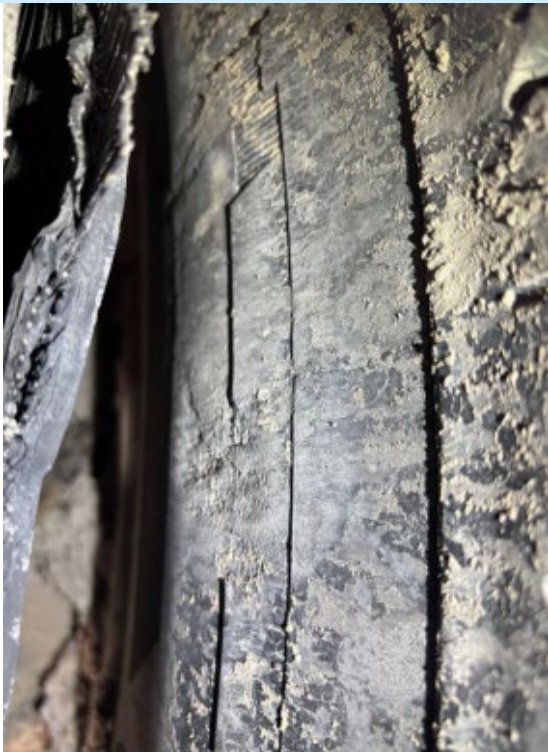
High potential incident IncNot0049373 Open cut coal mine	<p>A service truck was parked in a maintenance workshop when the inside wall of the right-hand rear tyre failed, rapidly deflating.</p> <p>Maintenance personnel were walking in the vicinity just before the tyre burst. At the time of the burst, the maintenance personnel were not in direct line-of-fire but were behind other equipment in the workshop.</p> <p>Rock damage to the inside wall of the right-hand rear tyre caused the separation and failure of the shoulder. The tyre failed at this point.</p>

<p>An exploding tyre can have catastrophic consequences.</p> <p>Tyres should be inspected as part of pre-use inspections to include checking for rocks stuck between dual tyres.</p> <p>Operators should receive training to assist them to identify tyre defects.</p>
