## Investigation report

Report into the death of Mark Daniel Galton at  
Boggabri Coal Mine on 21 May 2014

Report prepared by the NSW Mine Safety  
Investigation Unit

Published report date: August 2015

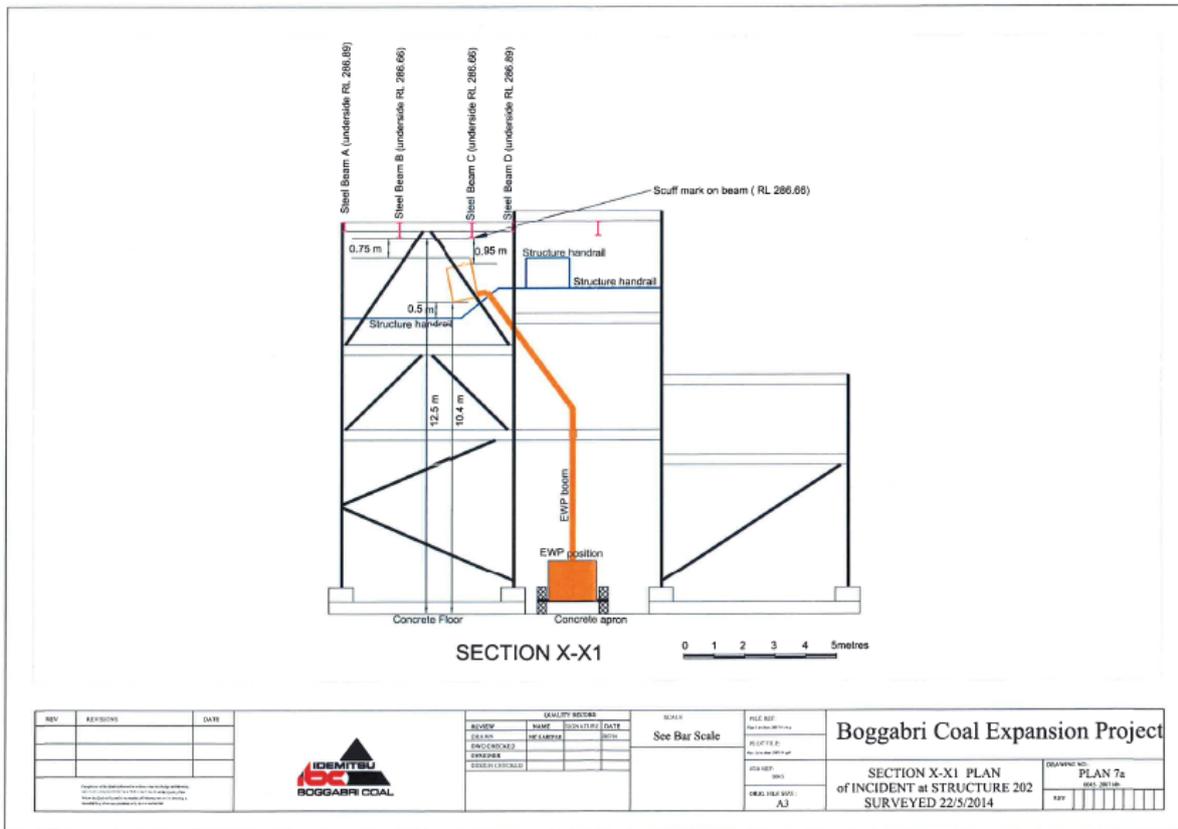
The position of the platform was rotated to the right relative to operating the platform control console and approaching parallel with the raised jib and boom.

Figure 21: Incident X-X1 cross section plan – view towards north east.

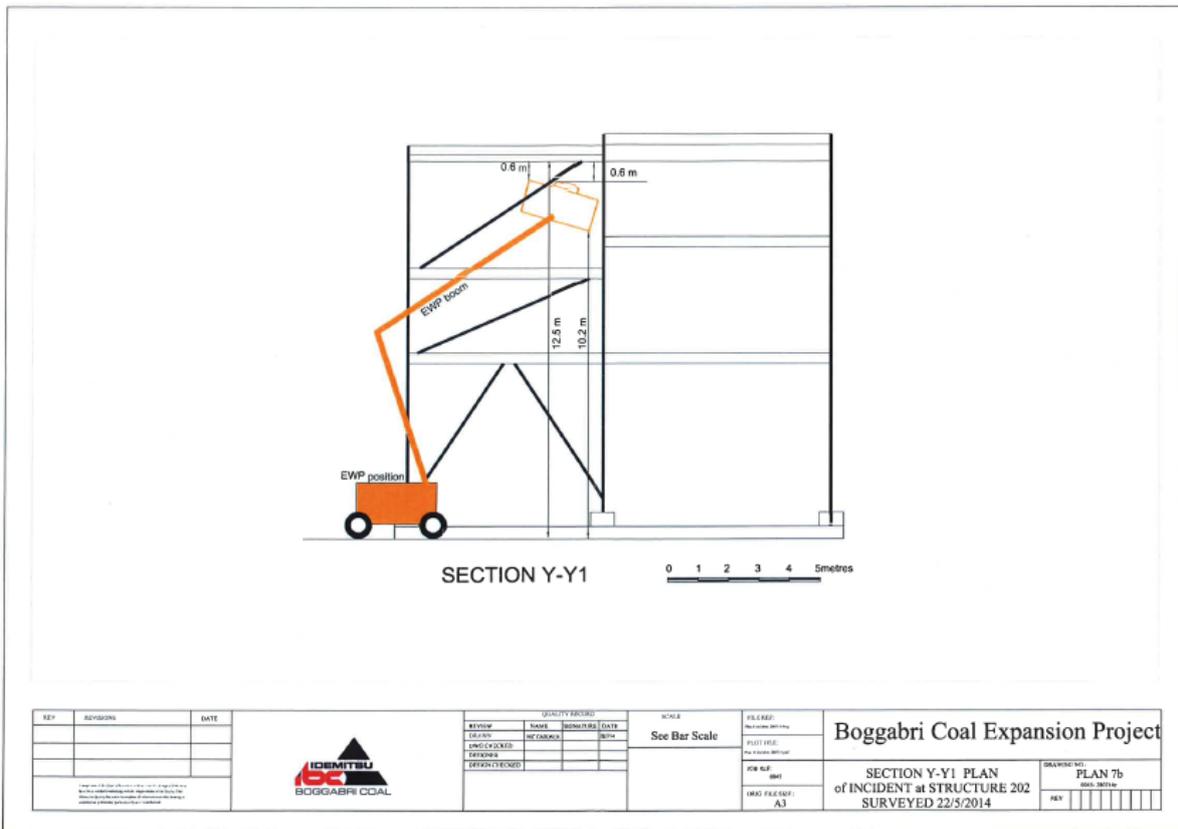
Figure 22: Incident Y-Y1 cross section plan – view towards north west

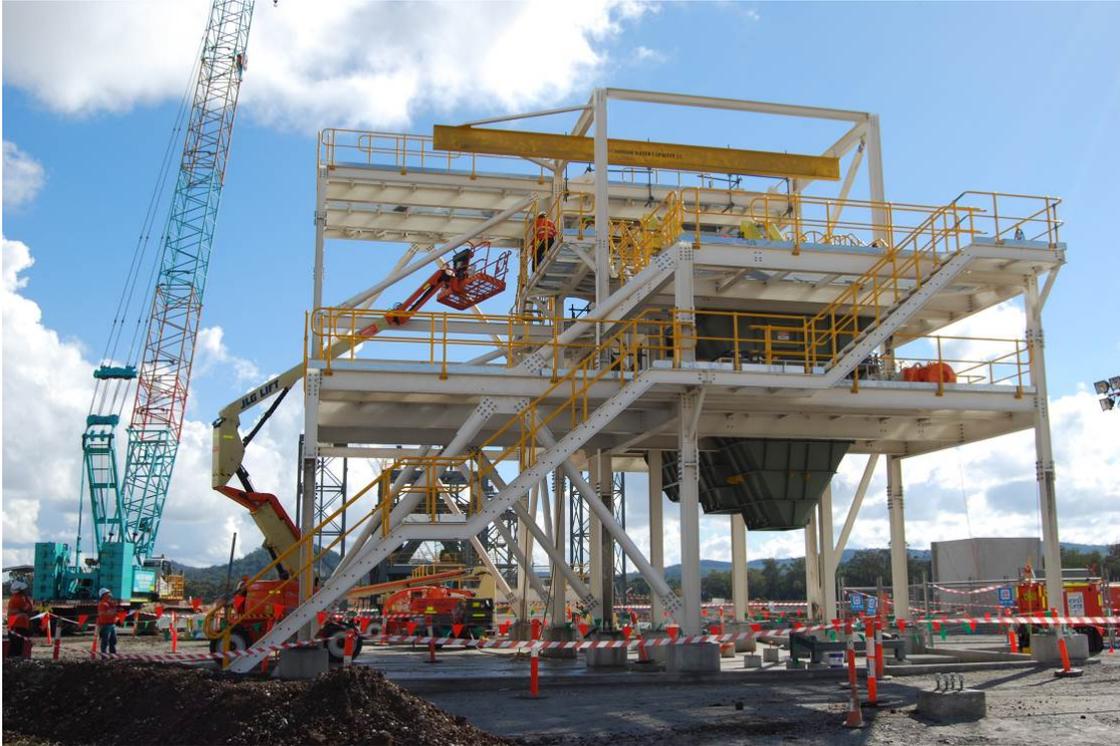
Figure 25: View north west towards main access stairway onto ST202 taken during the process of lowering the platform from under the third floor level.

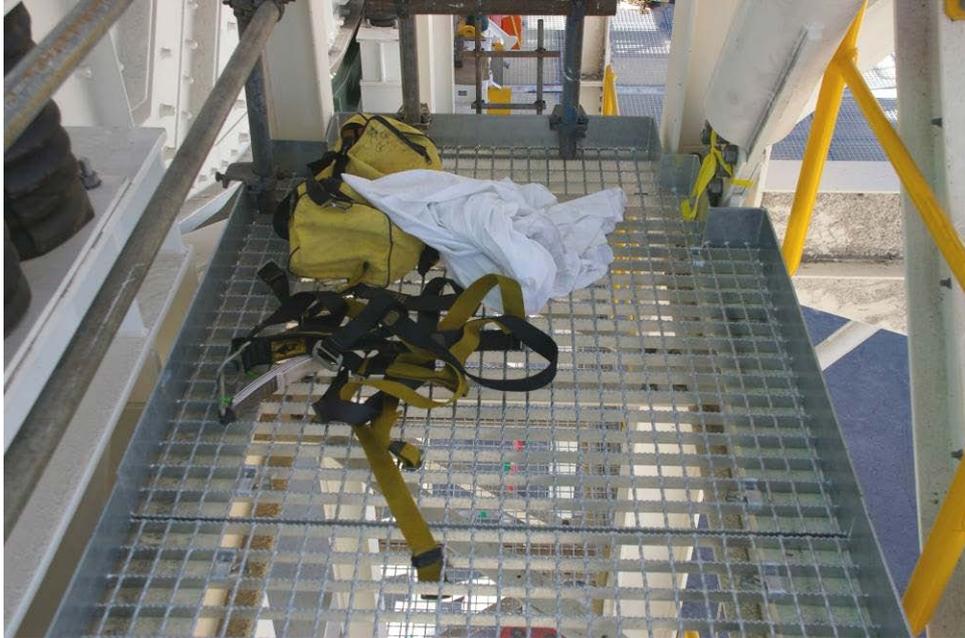
Witness accounts are not clear as to whether Mr Galton's yellow tool bag, which was fully loaded with tools and was found on the gantry walkway after the incident was in the platform at the time of the incident.

**Figure 27:** Mr Galton's yellow tool bag and a working at heights harness found on the walkway adjacent to the platform.

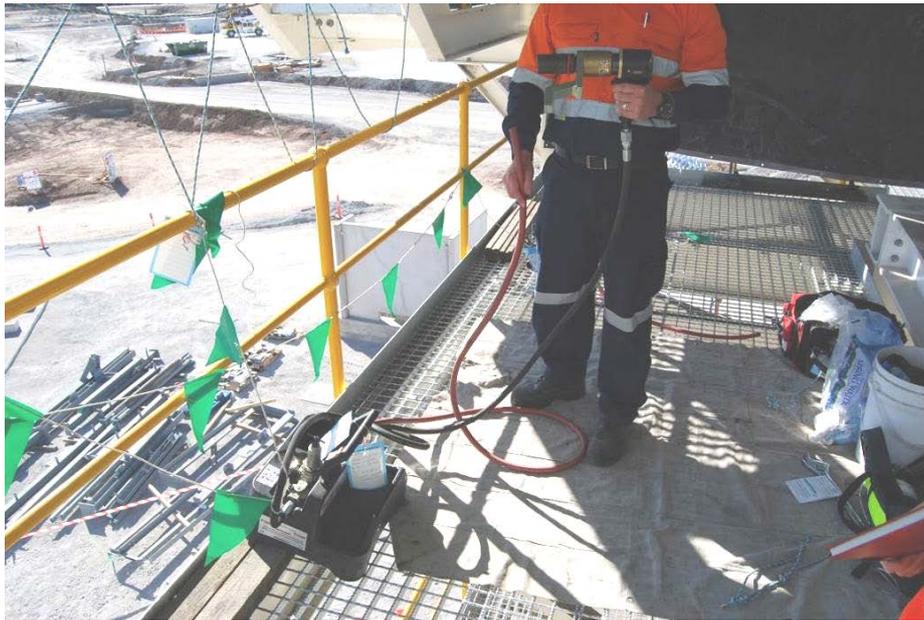
Figure 28: Photograph of a person holding the rattle gun and air hoses leading to and from the air receiver box all of which were in the platform with Mr Galton.

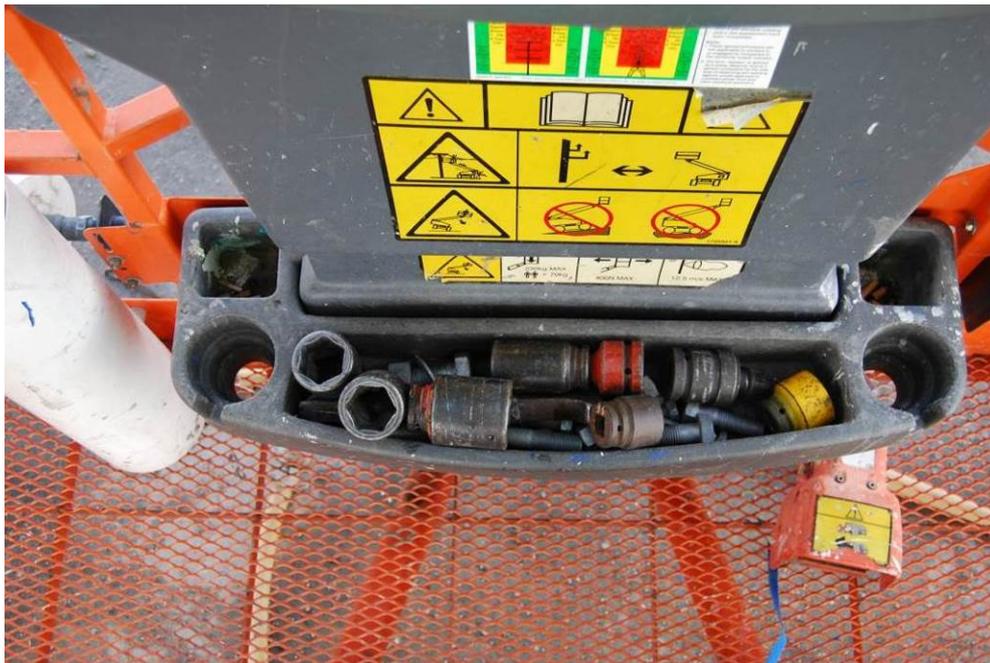
Figure 29: Photograph of items found in platform console storage bin.

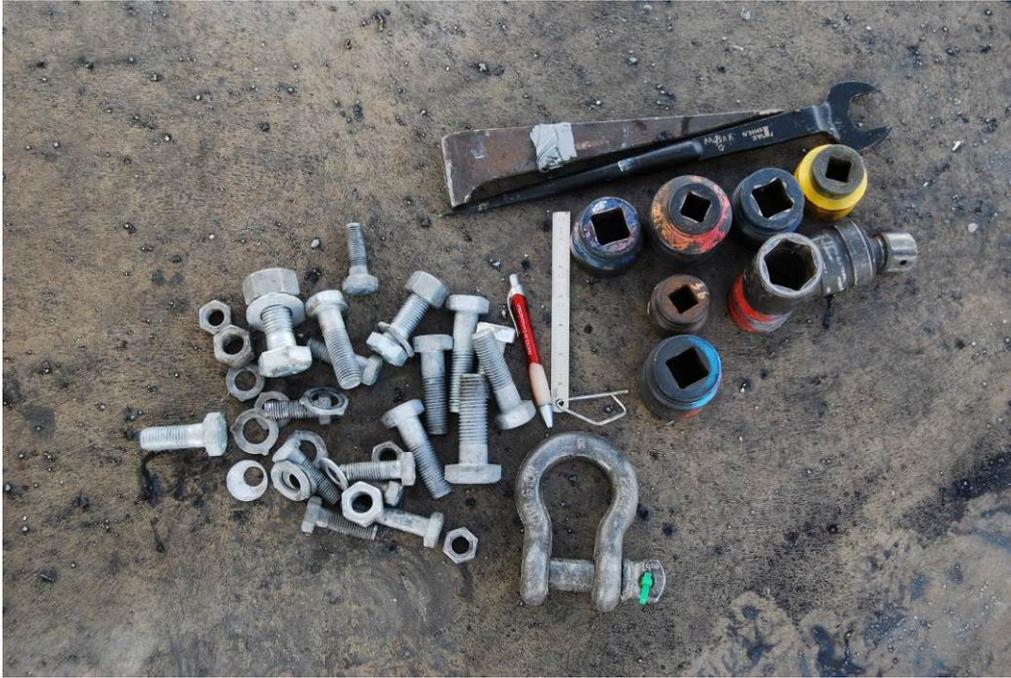
Figure 30: Photograph of items including tools rattle gun sockets, various size nuts and bolts found in the platform console storage bin and from the platform floor.

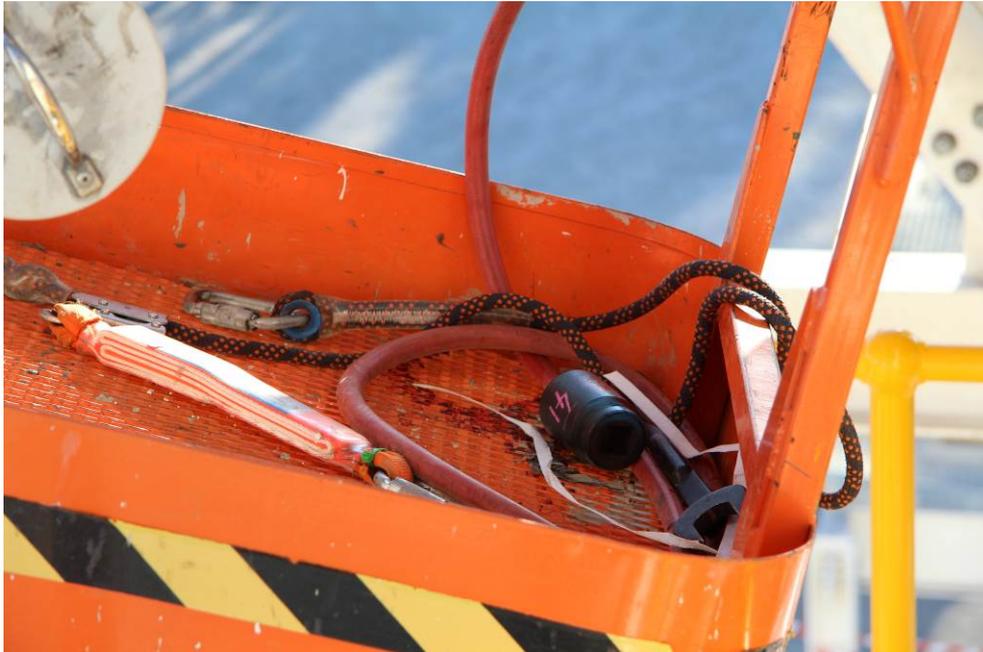
Figure 31: Photograph of PPE lanyard, shifter, red hose remnants, shifter and small plastic bottle found on the platform floor near the exit door.

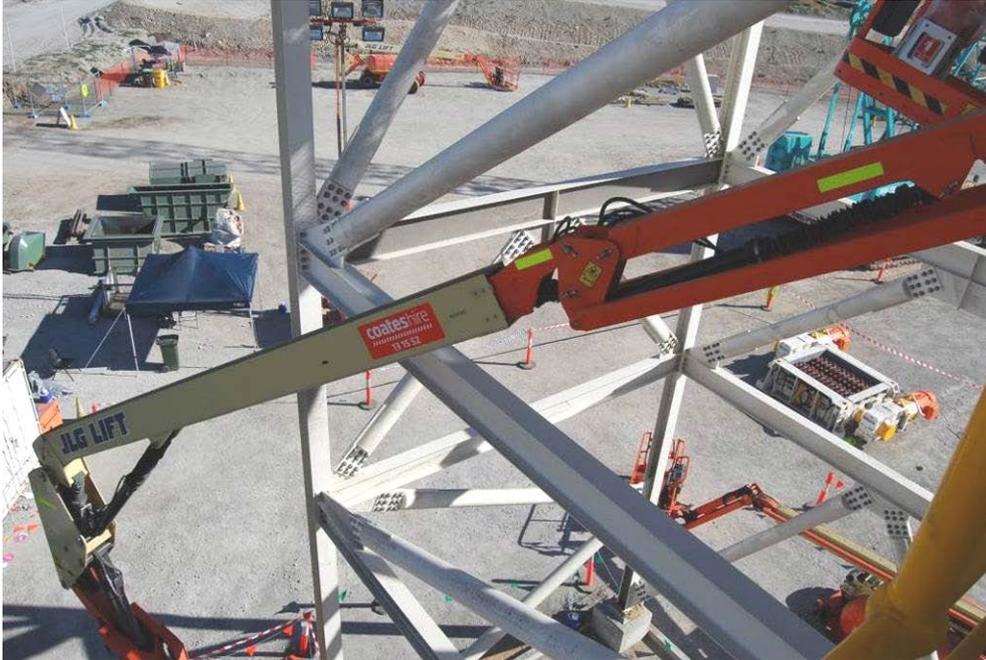
The platform was observed to be rotated to the right (in relation to the operator console position) and close to being parallel with the raised jib. The fly boom was raised but not extended. The base boom was raised.

Figure 34: View from the walkway of the position of the raised base boom, fly boom and jib in relation to the rotated platform.

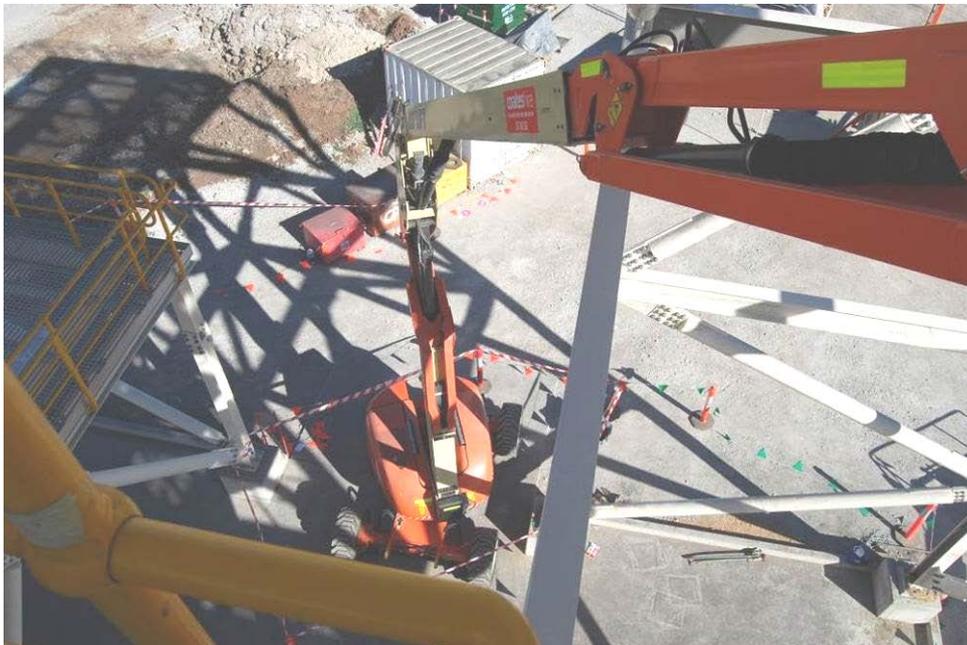
Figure 35: View looking down from the walkway of the positioning of the jib, fly boom and base boom in relation to the position of the MEWP base.

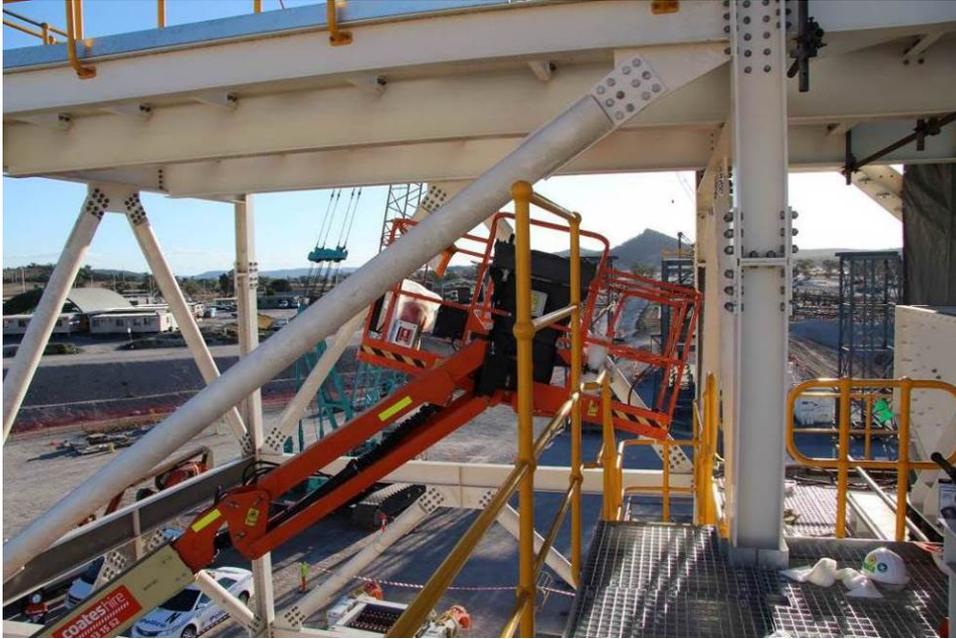
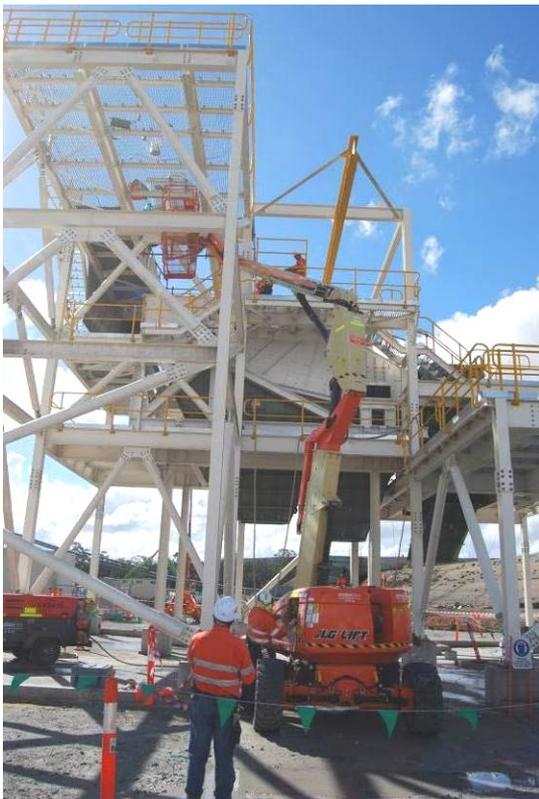
The position of the platform after the recovery of Mr Galton was observed to be rotated on the articulating jib rotator parallel with and to the left hand side of the turntable of the MEWP. The platform was across the top of two yellow painted handrails of steps on a walkway under the third floor level of ST202. The platform was lowered onto the top handrail of the steps during the recovery of Mr Galton.

**Figure 36: Platform and articulating jib position in relation to the stairway handrail.**

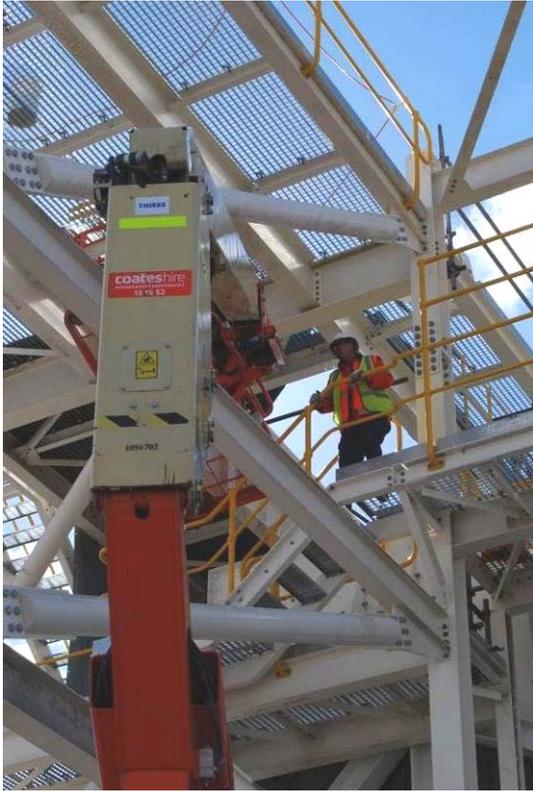
**Figure 37: Platform, jib, fly boom and base boom position in relation to the turntable of the MEWP and ST202. Photo taken while lowering of the platform from the ground control box of the MEWP on 23 May 2014. Spotters were positioned on the second floor walkway and on the ground level during the lowering of the platform.**

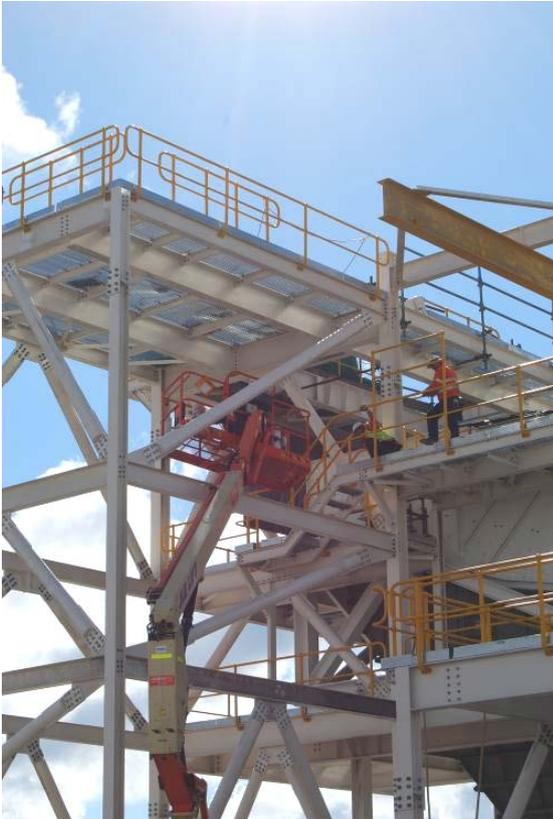
**Figure 38.** View of the base boom, upright and main boom position in relation to the second floor and third floor horizontal steels, the angled cross brace connecting floor the two floors and the handrail of the second floor walkway. The spotter is standing on the second floor walkway observing the platform movement controlled from the ground control box. Photo taken during lowering of the platform on 23 May 2014.

Observation during lowering of the platform after the incident identified that the platform initially required to be moved horizontally sideways to clear the top of the handrails and then lowered adjacent to the walkway handrail. The main boom moved closer to the steelwork.

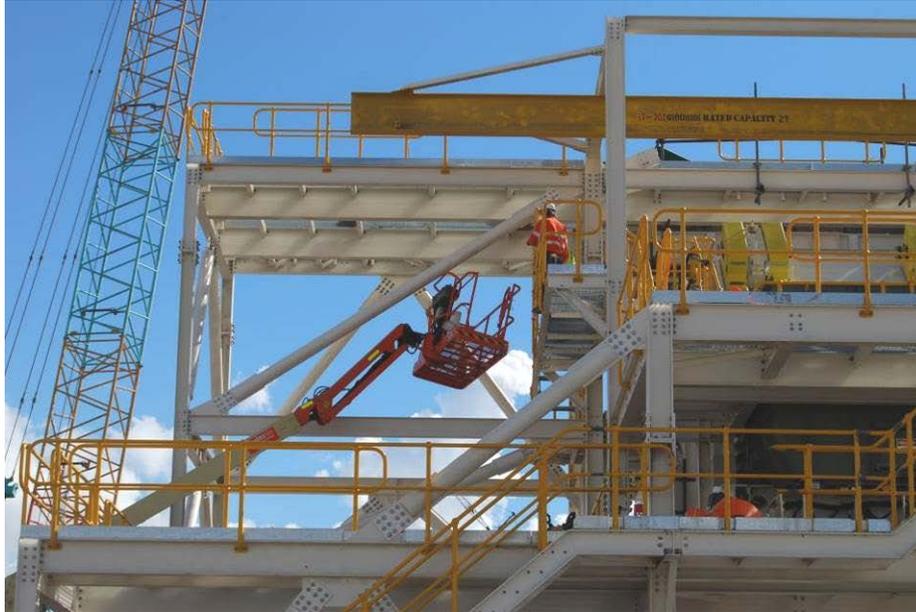
The platform was then rotated 90° to allow movement parallel to the walkway handrail and then moved horizontally through a space bounded by the second floor steelwork underneath the platform, the underside of the angled cross brace pipe work above the platform control console and the walkway handrail adjacent to the platform. The platform was also tilted downwards towards the handrail to pass underneath the angled cross brace.

**Figure 40: View of the platform rotated adjacent to the walkway steps handrail and tilted underneath the angled cross brace pipe. Photo taken during lowering of the platform on 23 May 2014.**

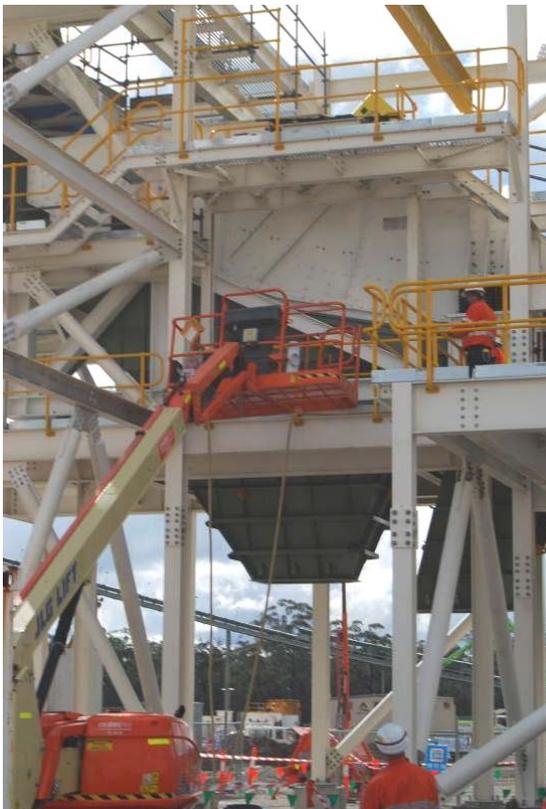
**Figure 41: View of the platform outside of the second floor main frame and being lowered vertically past the first floor. Spotters relocated to the first floor area and the ground level. Photo taken during lowering of the platform on 23 May 2014.**

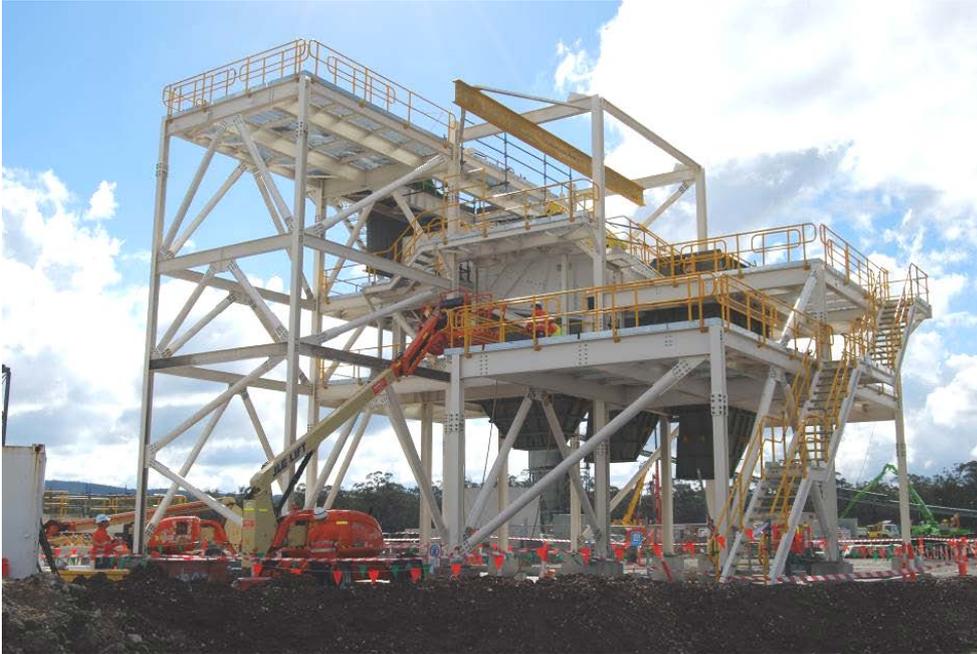
Figure 42: View of the platform outside of the main frame and being lowered past the first floor. Spotters relocated to the first floor area and the ground level. Photo taken during lowering of the platform on 23 May 2014.

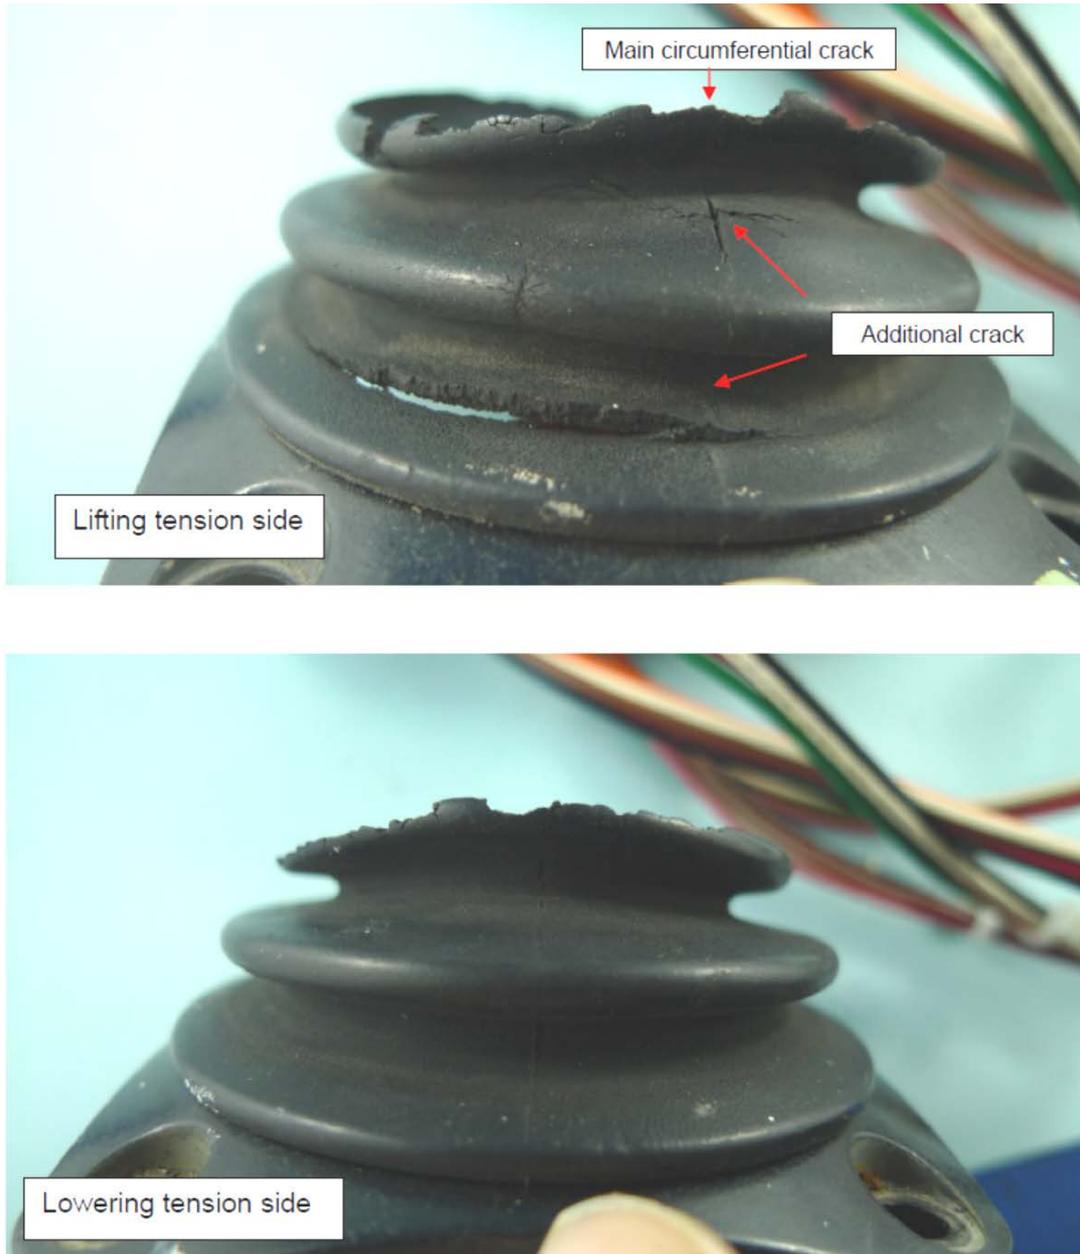
Figure 44: Extract of Bureau Veritas report – Figure 3.

*'Visual examination of the joystick unit indicated the absence of mechanical-related failure which could have caused the possible malfunction of the unit. The primary damage was identified to be the rubber protective boot cracking. However the condition of the circuit board was also found to be less than optimal which had been introduced during the manufacturing process. Further investigation would be required to verify the functionality of the circuit board.'*

Figure 3 Views showing the multiple crack indications below the major circumferential crack on the lifting tension side, while the lowering tension side was free of any visible damage.
