# **Investigation report**

Report into the serious injury of a worker at the Mt Arthur  
Coal Mine on 10 August 2017

Title: Investigation Report: Report into the serious injury of a worker at the Mt Arthur Coal Mine on 10 August 2017

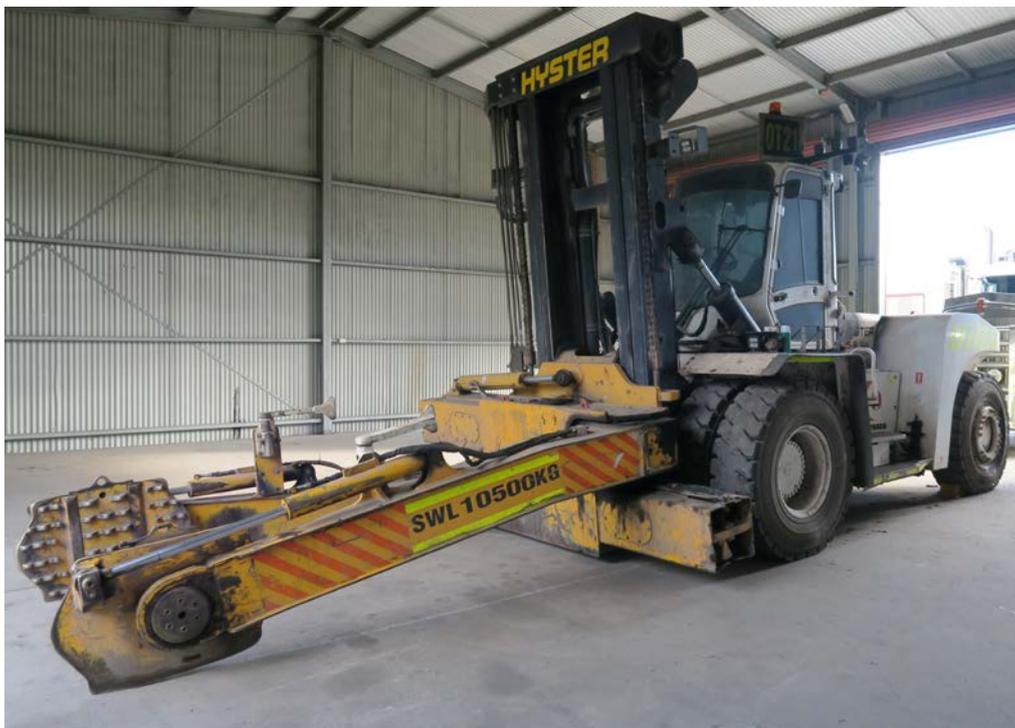
**Image 3.3 - Hyster 25-9 tyre handler involved in incident.**

The Hyster 25-9 tyre handler is designed to have rubber seals fitted along the inside bottom edge of its engine covers, and on each side of the frame of the engine bay where the engine cover closes on it. Examinations showed that the rubber seal was missing from the inside edge of the left side engine cover of OT21 at the time of the incident. They also showed that the seals at each side of the left-hand engine bay did not make full contact with the engine cover frame. These seals are only designed to reduce noise and protect paint, and not to prevent liquids entering the tyre handler's engine bay. However, it is likely that if the engine cover had been better sealed, the amount of diesel that entered the engine bay during the incident would have been reduced.

The proximity of the tyre handler's filling neck to its engine bay was examined during the investigation. Its design was found to meet the requirements of AS2359.6-2013 for 'Self-propelled industrial trucks, other than driverless trucks, variable-reach trucks and burden carrier trucks'. Part 4.5.2.1. provides that

It is highly unlikely that the above requirements in relation to the drainage of 'spillage or leakage' would extend to preventing high volume flows close to 800 litres per minute. With effective engine cover seals in place, it would be reasonable to expect that the raised lips beneath the engine cover and around the filling neck would be sufficient to prevent the ingress of spillage or leakage into the engine bay of the tyre handler.

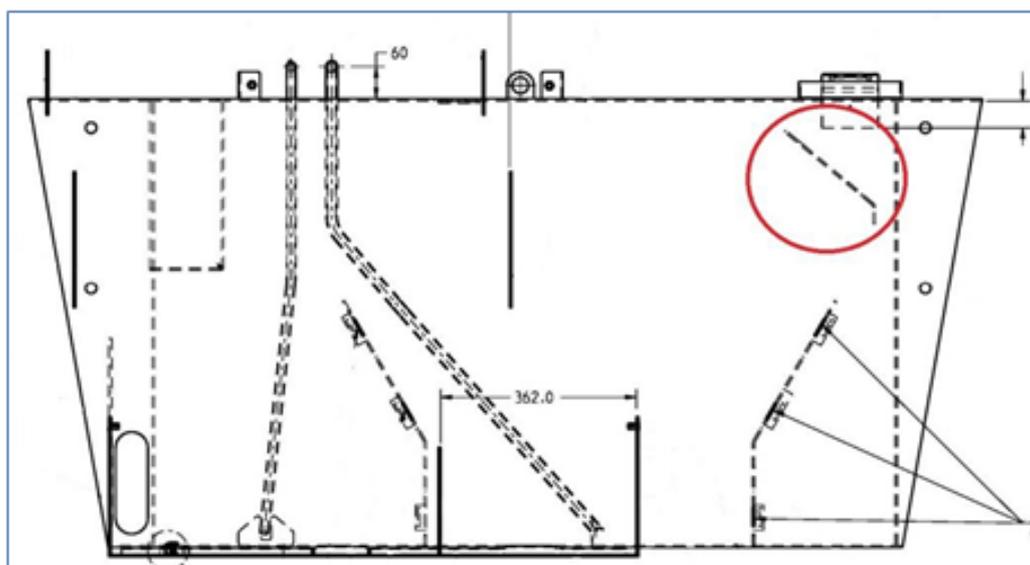
Image 3.6 - Internal view of fuel tank of Hyster 25-8 tyre handler.

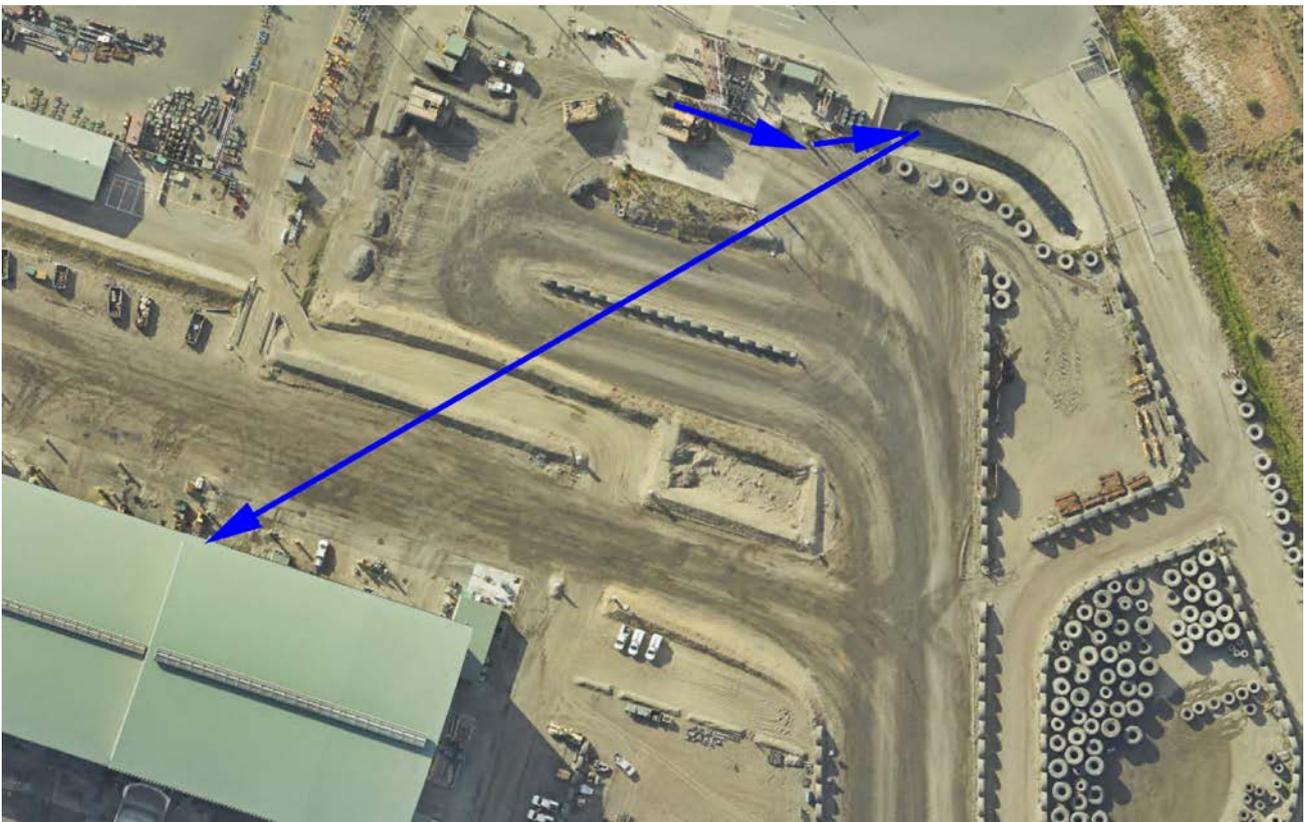
The injured worker ran in an easterly direction. He knew that the sleeve of his shirt was on fire and took the shirt off as he ran. He knew that there was an emergency shower at the refuelling facility but considered it to be too close to the fire to stop and safely use it. After he took his shirt off, he realised that his hair was on fire. He continued to run to a drain at the eastern end of the refuelling facility. He put his head into mud that was in the drain and extinguished the fire in his hair. He was assisted by another worker who escorted him to an emergency shower in Bay 18 of the mine's workshop.

Image 3.10 - Path travelled by the injured worker following incident.
