Trade &
Investment
Mine Safety

Investigation report

Investigation into a fatal collision between a Caterpillar 793D haul dump truck and a Toyota Landcruiser at Ravensworth open cut mine on 30 November 2013

March 2015

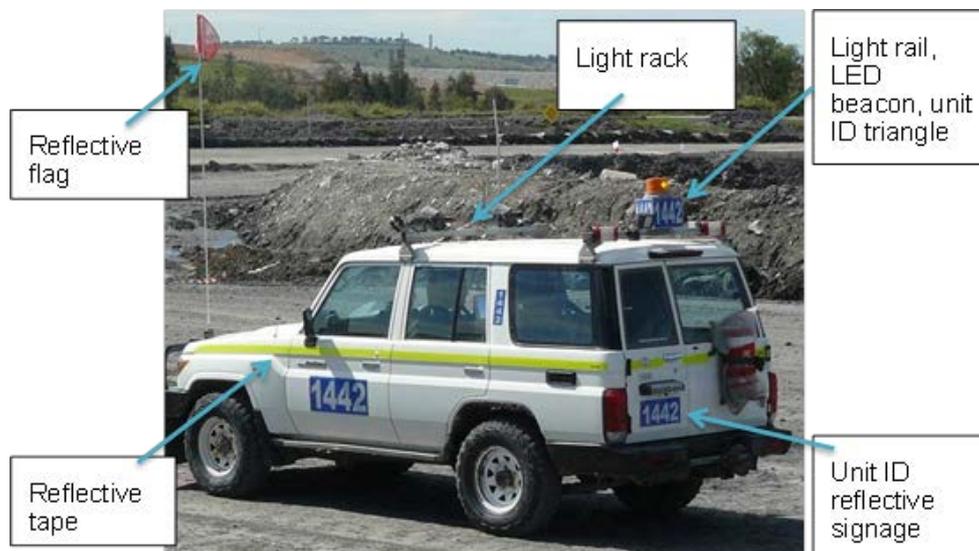
Figure 4. Photograph of a similar vehicle, taken by investigators at the mine on 2 December 2012.

The STMP required that when in the mining supervisor's district (i.e. on haul roads) all vehicles below three metres in height exhibit a reflective flag or a red light on a pole to a minimum height of three metres and at all times use a flashing orange beacon (see Figure 4). All vehicles and mobile equipment used on the site were also required to clearly display a unique reflective vehicle identification number to facilitate positive communications and have a two way radio.

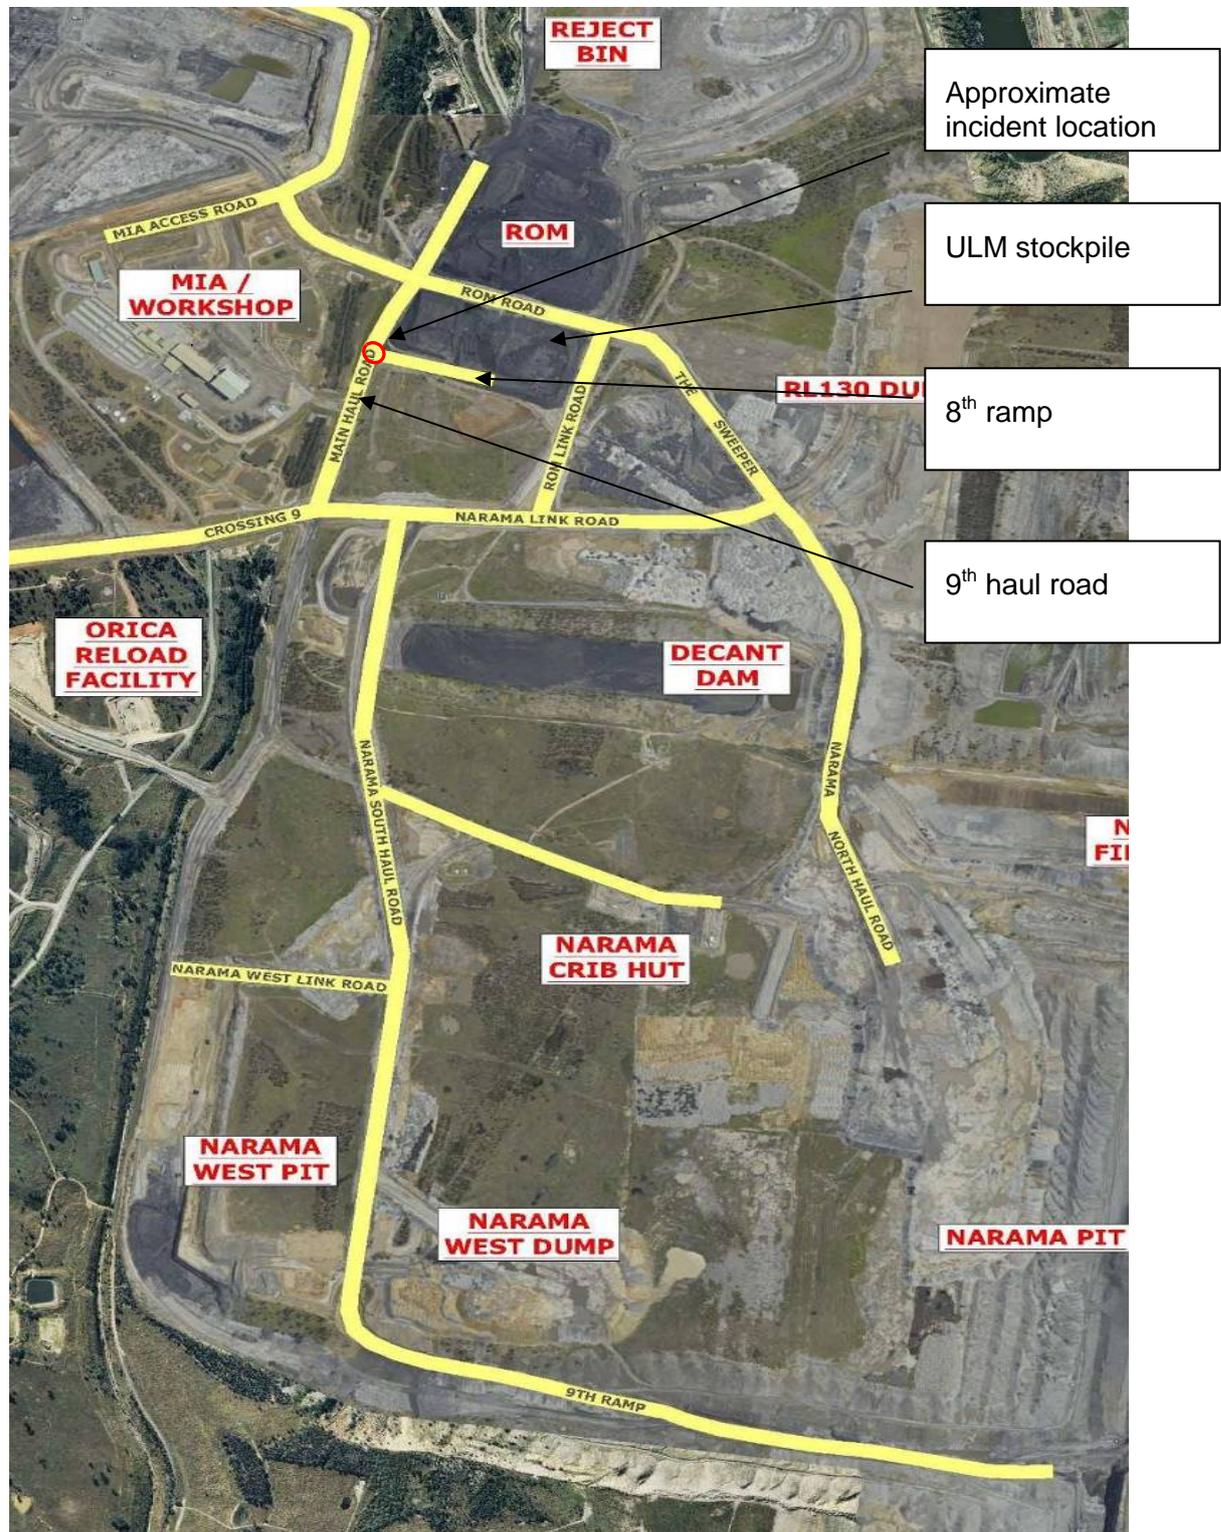
Figure 7. Extract from the mine's mine roads plan.

The incident occurred on the 9th haul road, near the T-intersection (the intersection) of the 8th ramp and the 9th haul road in the Narama area (see Figure 7).
