### **Investigation report**

Worker suffers serious burns while using an angle grinder to cut an intermediate bulk container (IBC)

June 2025

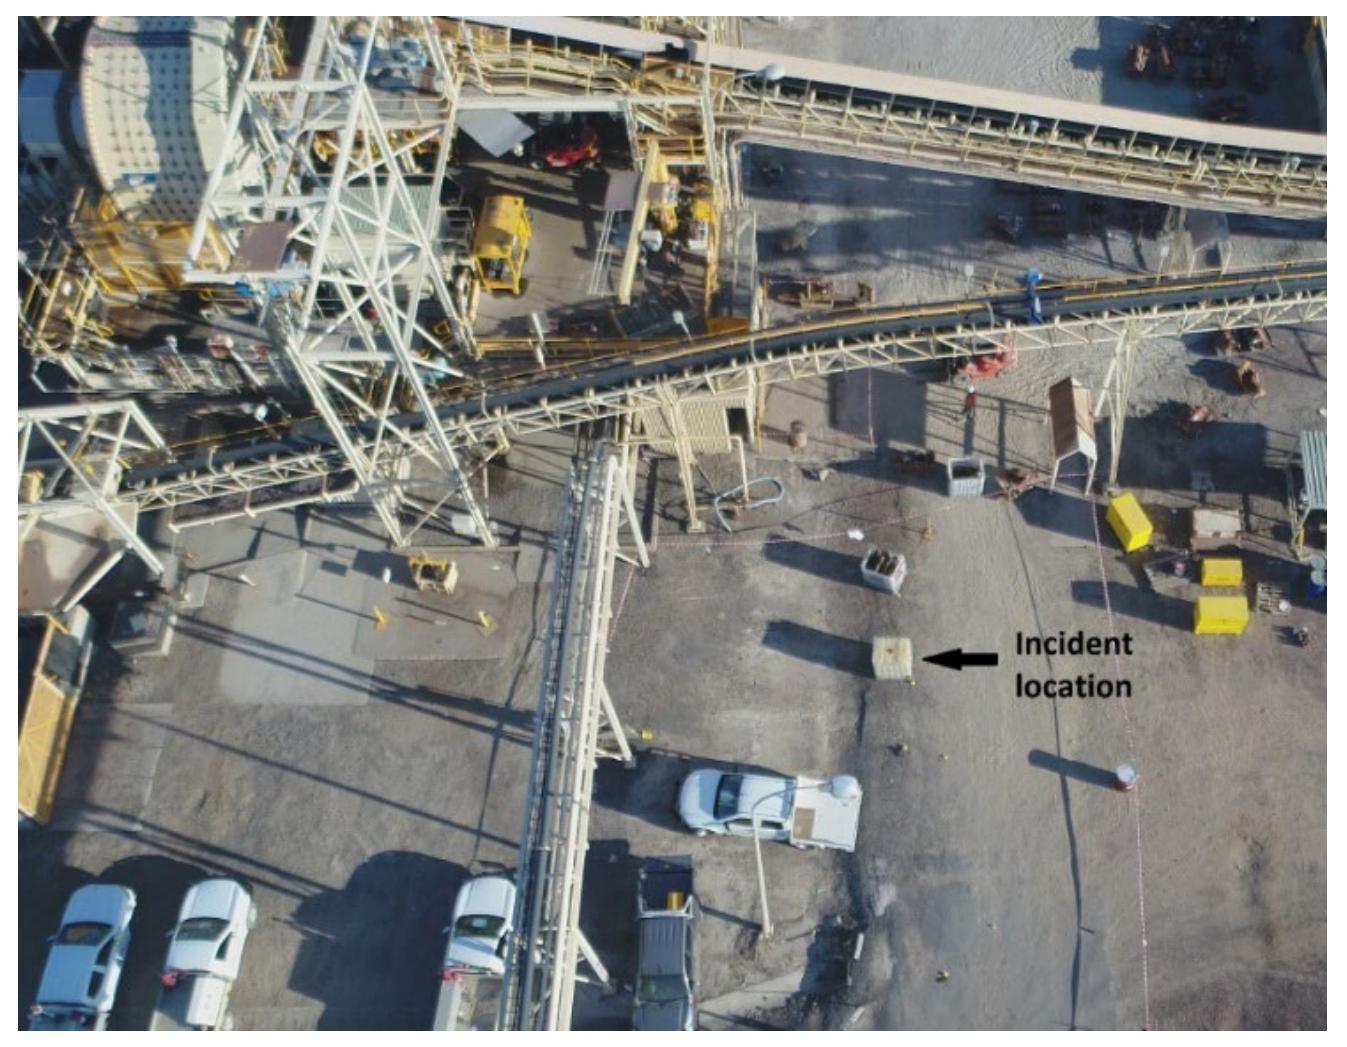
Figure 1: The location of the incident

A forklift operator retrieved an IBC from a used IBC storage area and transported it to an open area of the processing plant. The IBC had not been washed. It contained a residual amount of a liquid substance (Fischerchem Collector C503) that was stored inside it. The substance was manufactured in China and was shipped to Sydney in IBCs. It was transported to the mine and used to process mined ore.

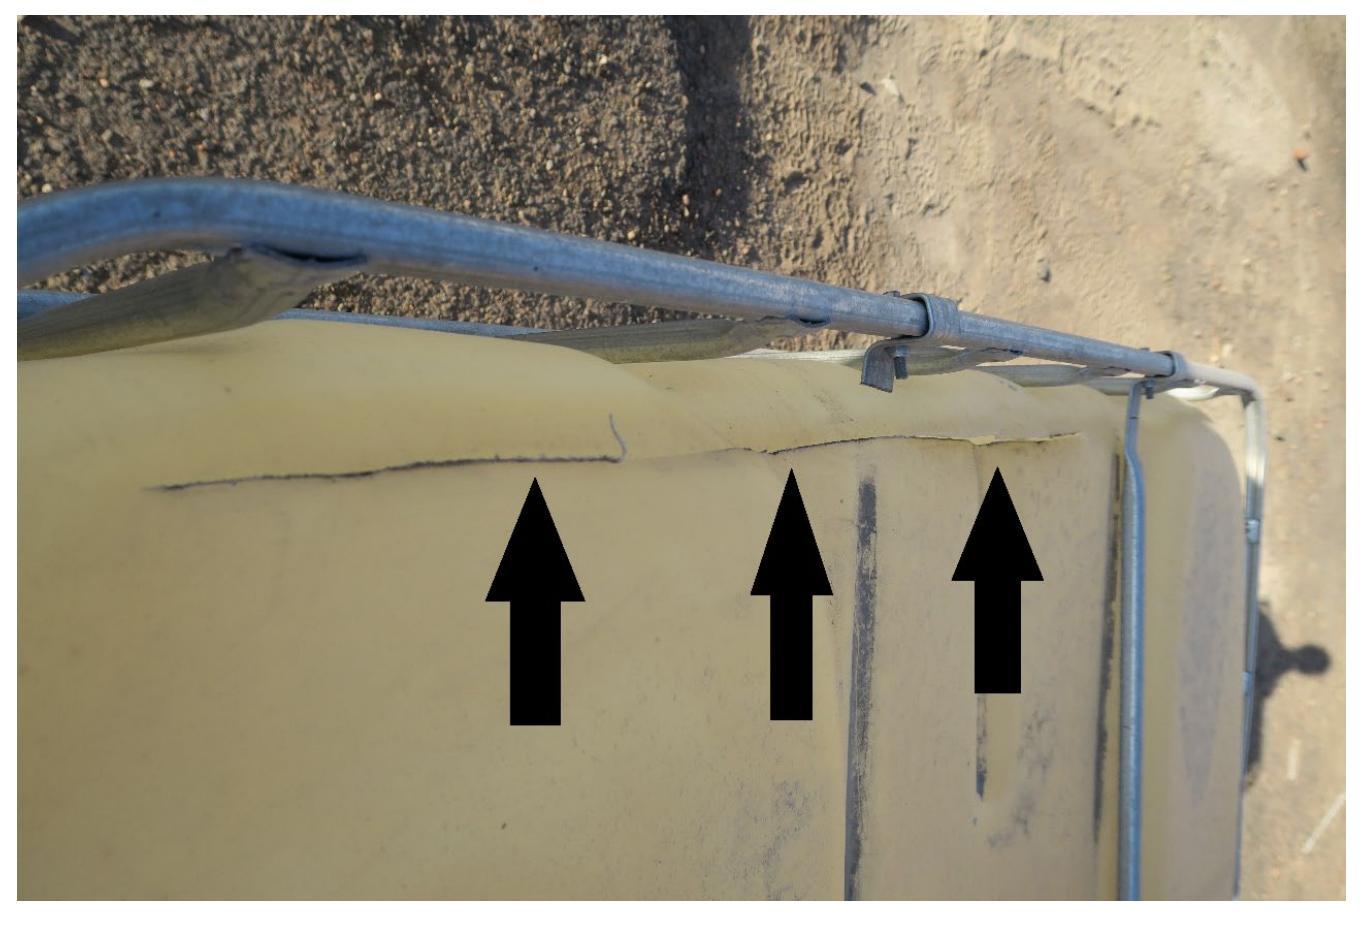
Figure 2: The cut that was made along the top of the IBC

The worker used the angle grinder to cut a strip along the top of the IBC as well as the 2 metal straps at the top of the IBC. He removed one of the straps and left one of the straps attached to the frame at one end.

Vapours from inside the IBC reacted violently with heat or sparks produced by the angle grinder.

- 12. The practice of cutting the tops from IBCs occurred regularly at the mine. However, the task was ordinarily performed using a reciprocating saw that did not produce as much heat as an angle grinder.

- 13. The mine operator's hot work procedures were not followed at the time of the incident. The procedures required a hot work permit to be issued for using the angle grinder, which involved assessments of relevant hazards and risks to be undertaken. The injured worker did not believe that the hot work permit system applied to the work that he was undertaking.

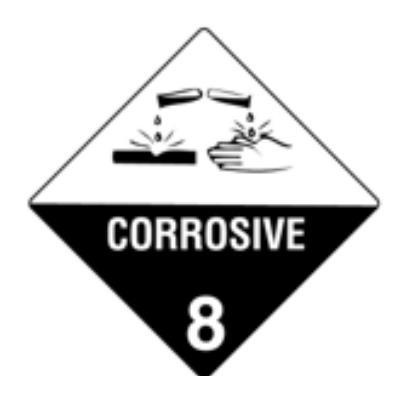
#### Figure 3: GHS Corrosive hazard pictogram

7. There were no warnings on the labell afixed to the IBC about the substance's flammable properties. The only safety-related GHS hazard pictogram on the IBC related to its corrosive properties.
