# Safety Alert

## Double fatality after unintended initiation of explosive device

## Safety Alert SA25-06

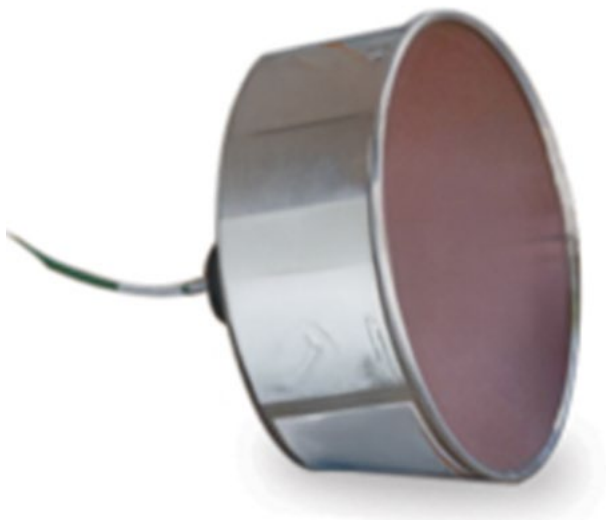
Picture 1: Example of a ballistic disc explosive device

- Review their risk assessments regarding the use of explosives on site.
- Reconsider the need to use ballistic disc explosive devices in mining applications.
- Consider reasonably practicable alternative methods for clearing blockages in stopes.
