## **Compliance audit program**

M1530 – Paxtons Mine

**Macapika Pty Ltd**

*May 2026*

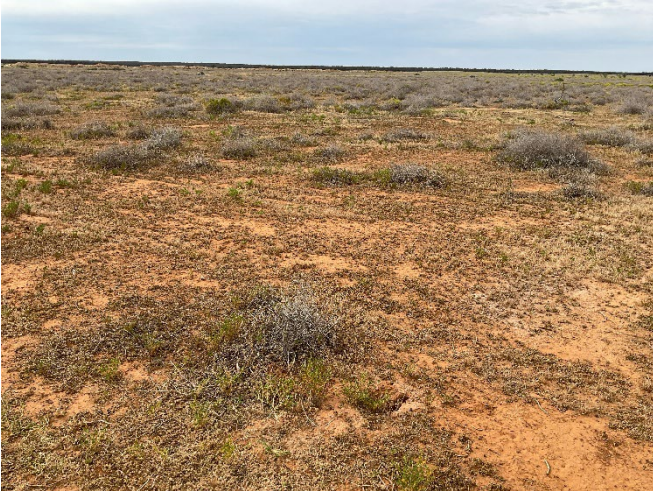
The leaseholders carried out assessable prospecting operations over the past 2 years. The requirements under condition 4 were triggered and an assessable prospecting operations application was required. APO0001614 was approved on 1 December 2023 with activities drilled and rehabilitated at the time of the audit. A sample of these completed activities were inspected during the audit and are shown in figures 1 - 3. Request for rehabilitation sign-off had not been sought.

Figure 1: Air core drill hole PAX001

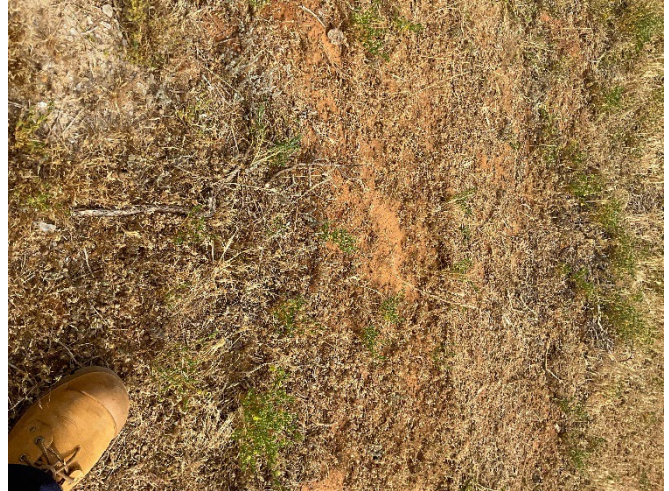
Figure 2: Air core drill hole PAX002

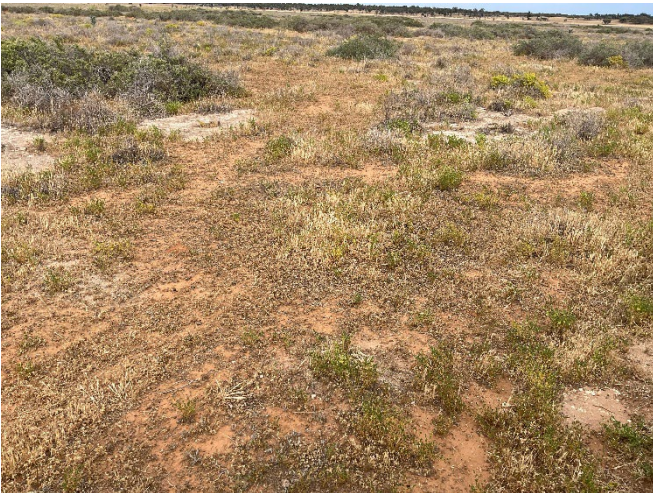
Figure 3: Air core drill hole PAX003

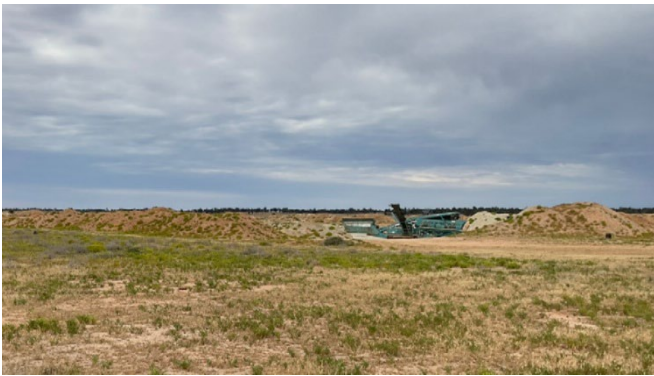
The mining operations of the Paxtons Mine were carried out within the boundaries of ML1530. No environmental harm was observed at the sites inspected. The operations are conducted along a long shallow pit. The small processing plant in the active area (Figure 4) was positioned at one end of the pit and was used for crushing the extracted material. The site was not in operation at the time of the audit. Generally, the site was tidy with minimal potential for environmental harm.

Figure 4: The processing plant in the current mining operation area

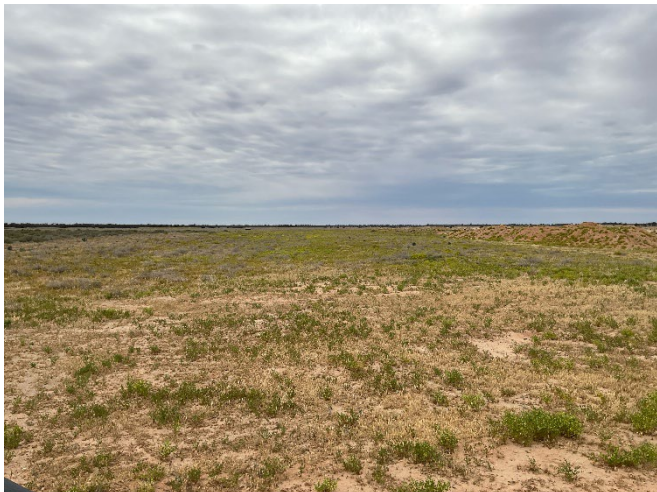
Clause 5 required rehabilitation to occur as soon as reasonably practicable after disturbance. Paxtons Mine was a large mine. Rehabilitation of the previously mined area was completed (Figure 5). The rehabilitation was completed about 10 years earlier. Topsoil and other material were stockpiled around the processing plant in the active mining area ready to use for rehabilitation once operations were completed. Rehabilitation was observed to be occurring as soon as reasonably practicable.

Figure 5: Rehabilitation of the past open pit

Site operations were not completed but were intermittent. Operations were planned to recommence. Achieving final land use was not required at the time of the audit, but the mine was on track to achieve final land use once operations cease. The previous open pit area, which was no longer used, was rehabilitated with no issues sighted on day of audit. No application was submitted to have this area signed off by the Regulator as rehabilitation completed.
