# Weekly incident summary

## Week ending 19 June 2026

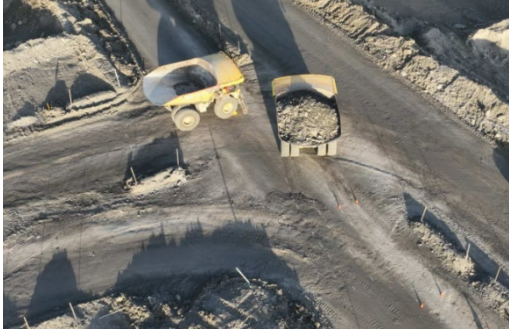
| Incident type | Summary | Recommendations to industry |
|---|---|---|
| Dangerous incident<br>IncNot0051541<br>Open cut coal mine<br>Roads or other vehicle operating areas | <p>Two 793 haul trucks driving at night narrowly avoided a collision at a T-intersection when one vehicle failed to give way to the other as per the site's road rules.</p> <p>The vehicles stopped about 4 m apart.</p> <p>The vehicle that failed to give way was travelling through the intersection at about 45 km/h.</p> | <p>Mine operators should continually review the suitability of collision avoidance technology as it evolves and new products become available.</p> <p>Refer to Layers 3 and 7 of the layered defence approach in the <a href="#">Resources Regulator's technical reference guide: Surface ROVOA</a>.</p> <p>Layer 3 focuses on operating procedures including road rules: specific guidelines for vehicle operation within the mine site.</p> <p>Layer 7 focuses on operator awareness. This layer aims to introduce technologies that provide information to enhance the ability to comprehend the immediate environment and understand potential hazards in the vicinity.</p> <p>For further information see the recently published safety alert and video:</p> <ul style="list-style-type: none"> <li>• <a href="#">SA26-04 Near miss between a haul truck and grader</a></li> <li>• <a href="#">SA26-04 video</a></li> </ul> |

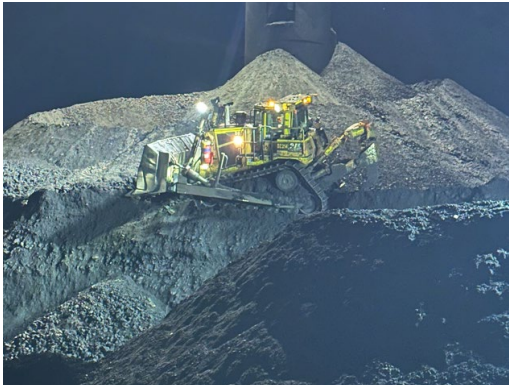
| Incident type | Summary | Recommendations to industry |
|---|---|---|
| Dangerous Incident<br>IncNot0051547<br>Underground coal mine<br>Ground or strata failure | <p>A bench on a stockpile slumped under the left-hand track of a dozer while the operator was in the process of constructing a spiral ramp.</p> <p>The dozer was unable to recover from the slump under its own power and the operator had to be rescued from the dozer.</p> | <p>Operators are reminded of the potential hazards associated with a dozer on a stockpile.</p> <p>Workers must be trained to operate dozers on stockpiles including being familiar with different coal properties and how this impacts material behaviour on stockpiles.</p> <p>Before starting work, supervisors and equipment operators should inspect and assess the work area to determine hazards. Planning for the work must include identification of hazards, risk assessment and control.</p> <p>For further information refer to: <a href="#">Technical Reference Guide: Stockpiles and reclaim tunnels</a></p> |
