# Weekly incident summary

## Week ending 25 September 2026

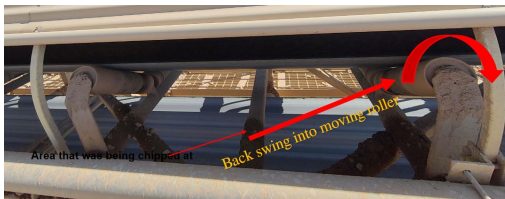
| Incident type | Summary | Recommendations to industry |
|---|---|---|
| Dangerous incident<br>IncNot0052082<br>Underground metals mine | <p>A worker sustained hand injuries when his hand was caught between an active roller and a conveyor belt.</p> | <p>When working near or around operating conveyors, guards must be in place where there is a risk of entanglement. Workers must remain</p> |

| Incident type | Summary | Recommendations to industry |
|---|---|---|
| | <p>The worker was conducting clean-up activities on a surface conveyor and used a rock hammer to remove build up from the trough frames. During the backswing, the tool became caught causing the operator's hand to be pulled between the roller and the belt.</p> <p>The worker was taken to hospital where pressure was released from their ring finger. The worker also sustained a fracture to their thumb.</p> | <p>clear of the conveyor belt, idlers and other entanglement points.</p> <p>Under no circumstances should a worker be using a rock hammer to remove material on an operating conveyor belt.</p> <p>Workers must be trained in relation to the hazards associated with common mining equipment such as conveyors.</p> <p>Mine operators should ensure that documented procedures are available for workers undertaking maintenance tasks. Conveyors must be isolated and tested for dead before maintenance work commences. Supervisors should ensure that the approved procedures are followed.</p> |

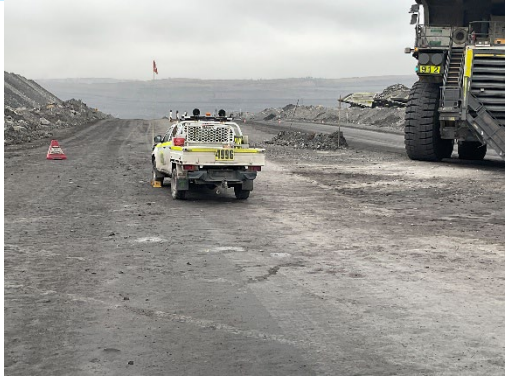
| Incident type | Summary | Recommendations to industry |
|---|---|---|
| <p>Dangerous incident<br/>IncNot0052098<br/>Open cut coal mine</p> | <p>A light vehicle (LV) failed to give way to a haul truck at an intersection on a main haul road, narrowly avoiding a collision.</p> <p>The haul truck was indicating to turn right at an intersection when the LV entered the intersection at 48 km/h failing to give way to the truck and travelling through the intersection.</p> <p>The truck operator observed the LV and stopped prior to turning into the intersection when it appeared that the LV was not slowing down to give way.</p> <p>The mine was operating under hierarchy where LV's give way to haul trucks.</p> | <p>Mine operators are reminded to implement a layered approach to managing vehicle interaction risks on roads and other vehicle operating areas.</p> <p>Consideration should be given to the controls outlined in the <u>TRG: Roads or Other Vehicle Operating Areas</u>, particularly:</p> <ul style="list-style-type: none"> <li>• Layer 2: Vehicle separation</li> <li>• Layer 3: Operating procedures, including road rules</li> </ul> |
