# **SAFETY ALERT**

# **Directional boring fatality**

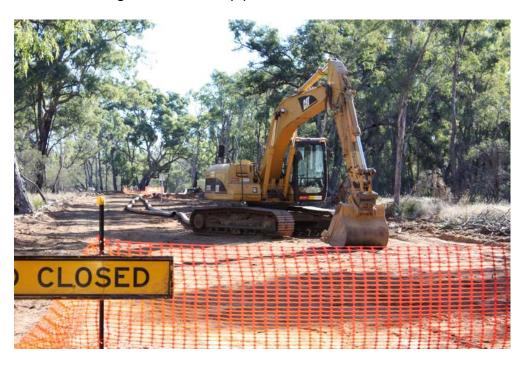
PE pipe was being installed beneath a creek using the 'directional boring' (horizontal directional drilling) method. A pilot hole was drilled then backreaming began, pulling a line of 200mm PE pipe behind the reaming tool. During this operation a cross-over sub failed and the drill-string separated from the reamer assembly and PE pipeline.

Preparation commenced for recovery of the pipeline by pulling it back through the borehole from the entry-end. A chain was tied to the pipe and the other end connected to an excavator. During the pulling process the chain broke. It appears that the elastic strain in the pipe recovered violently. The deceased person was standing in the zone of pipeline recoil.

- 1. Systems for ensuring safe operation of directional boring activities should be developed using good practice risk management principles.
- A safe system of work should be developed and implemented that includes fit-for-purpose equipment documented safe work procedures for handling and / or recovering pipe from the entry end and defined safe areas for people to stand that are outside potential danger areas in event the pulling system fails.

- 3. Consideration should be given to the measurement and understanding of loading forces when withdrawing pipe; defining safe loading forces; setting adequate safety factors; providing safeguards against the release of uncontrolled energy; and restricting people from entering danger zones using hard barriers.

- 4. A review should be undertaken of the use of chains for pulling / snigging refer to Safety Bulletin *SB09-03 Broken pull chain results in fatality*.
